## Hydraulic and Morphological Consequences of Bank Protection Measures along the Jamuna River, Bangladesh

**Keywords:** Brahmaputra/Jamuna River, bank protection, channel stabilization, field investigation, Bandal, spur dyke

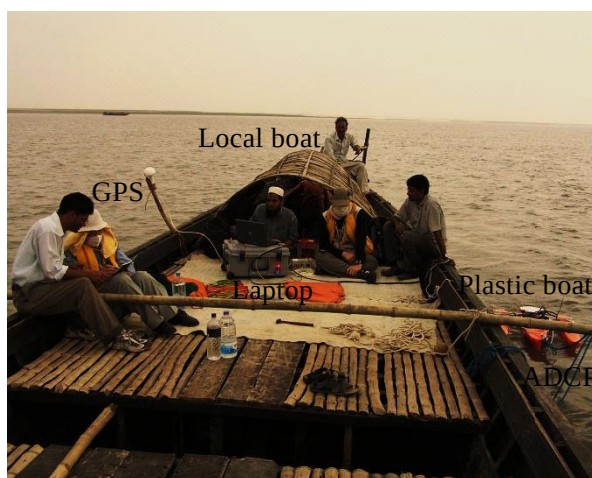
As a field-based applied research, field trips and field measurement systems are of great importance. In this study, a measuring system consisting of an ADCP (Acoustic Doppler Current Profiler) and a GPS (Global Positioning System) is used to record the 3D velocity vectors in the river. The ADCP (1200kHz, WH-ADCP Rio Grande by Teledyne RD Instruments) was mounted downward beneath the water surface on a particularly designed plastic boat. And the plastic boat was dragged by a local wooden boat during measurements. The ADCP and the GPS are connected with a laptop installed with a real-time data visualization and data analyzing/post-processing program. A snapshot of the field measurement is shown in Photo1, with the specifications of the measuring system.

Photo1 Field survey on the Jamuna River

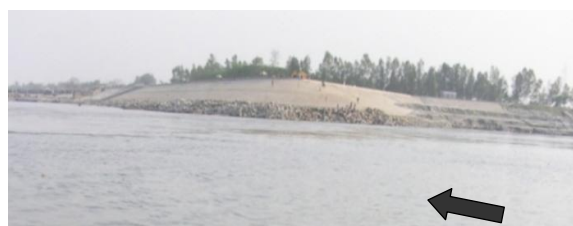
The old established town: Sirajganj is located in central Bangladesh, about 8km upstream of the Jamuna Bridge and about 110km northwest of the capital city: Dhaka. According to analyses results of satellite images, Sirajganj is observed to have the highest erosion rate in the catchment area (CEGIS, 2007). The erosion of the bankline since the 1950s has resulted in parts of the historic town fronting directly onto the river bank (Halcrow et al., 1994). In order to protect the town, revetment works were launched by the Bangladesh Government in 1998, known as Sirajganj Hardpoint. The hardpoint intends to control the shape of the BRE with the lowest level of intervention to the river flow. The hardpoint was constructed with cement concrete cubic blocks and consisted of a straight portion along the BRE together with a round upstream termination. The basics of the Sirajganj Hardpoint are listed in Table1 and a photo is shown in Photo2.

Photo 2 Sirajganji Harpoint

The Sirajganj Hardpoint is exposed to the main anabranch channel of the Jamuna River, receiving year-round hydraulic attacks. The hardpoint, especially the area near the upstream termination, has been almost damaged almost every year since 2007. Velocity measurements were conducted during March 22-23, 2008 and March 19, 2009. In addition, the bathymetry survey data around the upstream termination was collected from the branch office of BWDB.

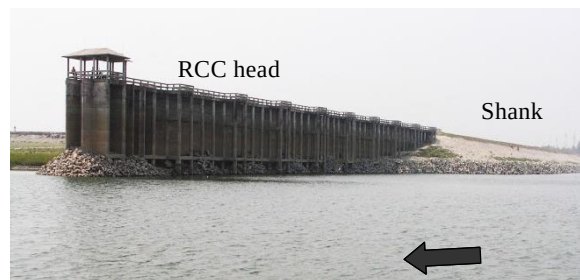
Since 1914, the bankline of this area has shifted towards west by around 5km (Halcrow, 1994). In order to protect the bank, two spur dykes were constructed in 2002. The distance between the two spur dykes is around 2.5km. The Betil and Enayetpur spur dykes basically follow the same design methods. Either of them consists of an earthen shank and a RCC (Reinforced cement concrete) head. The RCC head is not deep penetrated into the riverbed but is supported by in-situ casted concrete piles with a diameter of 0.5m. Therefore, the lower part will be permeable if the bed level is degraded enough. The connection between the RCC head and the earthen shank is in the form of a bell-mouth and has been found to be one of the weakest points according to past failure experiences. Although RCC blocks and geo-bags are dumped into the water to provide additional protection to the spur dykes, the earthen parts have suffered from damages frequently in monsoon seasons since their completion. The main parameters related to the Betil/Enayetpur spur dykes are listed in Tab.2.

Photo3 The Betil spur dyke

Photo4 The Enayetpur spur dyke

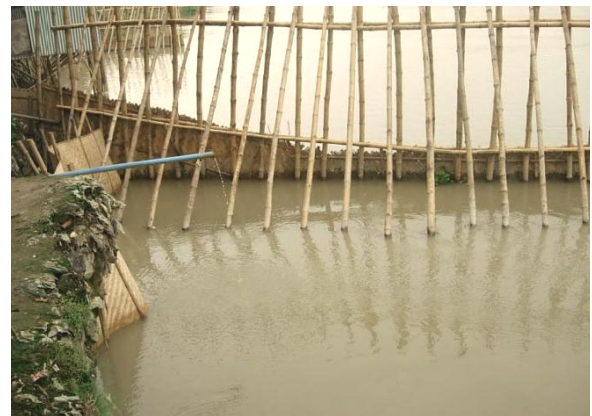
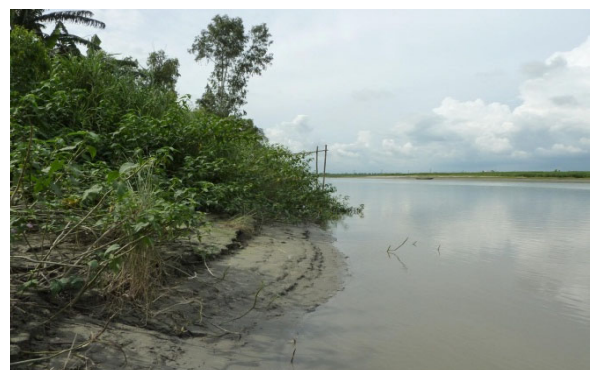
the water course with a length of about 10m and made an angle of  $50^{\circ}$ - $60^{\circ}$  to the bankline. The Bandal was made of groups of vertical bamboo piles with a spacing of 46cm. The diameters of the bamboo piles ranged from 6cm to 9cm. The piles were connected with each other by cross bamboos with a vertical spacing of around 75cm. Moreover, inclined bamboos were set at an angle of  $45^{\circ}$  to the bamboo piles to enhance the stability of the Bandal structure. The upper part of the Bandal was closed with bamboo thatch while the lower part is open. The Bandals were arranged in a group along the secondary channel of the river as show in Fig.2. The distance between two consecutive Bandals is around 32m. The details of one of the Bandals are shown in Photo1 which was taken during the field investigation in July, 2008. On the other hand, Photo2 demonstrates the sediment deposition behind the Bandal structure along the bank and the photo was taken in July 2009, one year after the first field trip. It is found that a large area of land is created behind the Bandal within only one year. The two photos give visible evidence on the deposition-promoting performance of the Bandals.

Photo 5 Randhunibari Bandal (July, 2008)

Photo 6 Randhunibari Bandal (July, 2009)
