## PAPER V

# Radioautographic Studies of the Materials Obtained from the No. 5 Fukuryu Maru Contaminated by Radioactive Ashes

Takehiko KIKUCHI, Hiroaki AKAGI, Hiroshi GOTO, and Gyoichi WAKISAKA

(The Second Medical Clinic, Faculty of Medicine, Kyoto University)

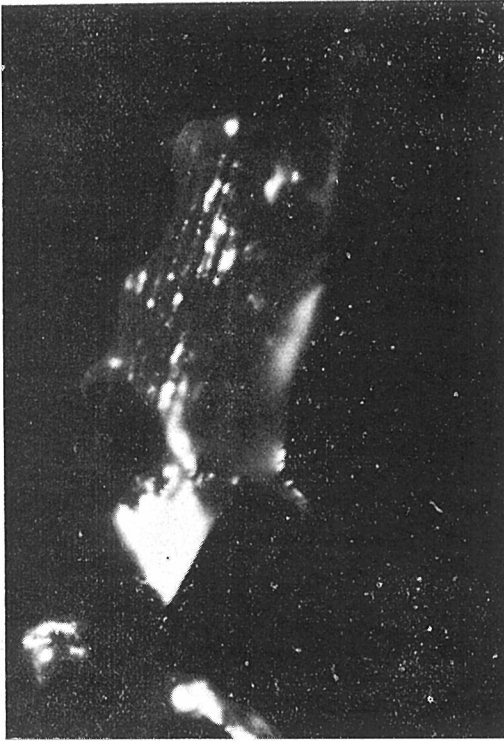
Fig. 1. Radioautograph of the caudal fin of the tuna.

1) Tuna. Survey radioautographs of the caudal and pectoral fins and skins of the tuna revealed spotted radioactivity. In the caudal fins, the radioactivity was especially high at the distal part. Projecting parts of the caudal fins showed also high radioactivity (Fig. 1). In the skins, the radioactivity was high at the contact points of scales. Fig. 2 shows a detail radioautograph of the scales.

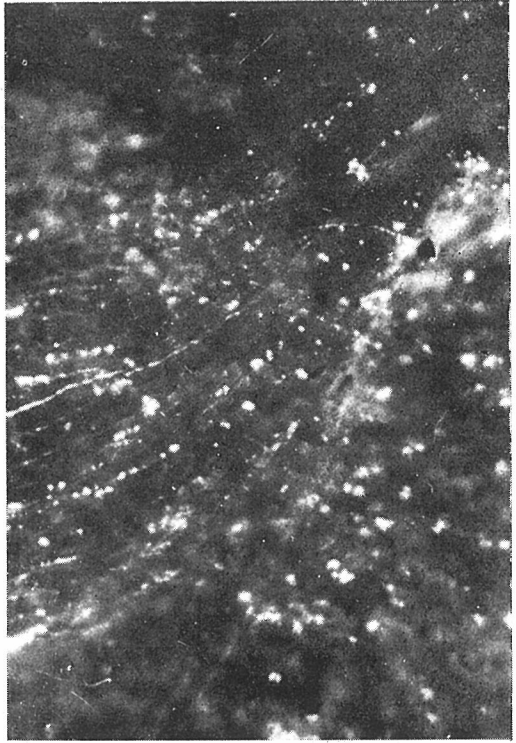
Fig. 2. Detail radioautograph of the scale of the tuna.

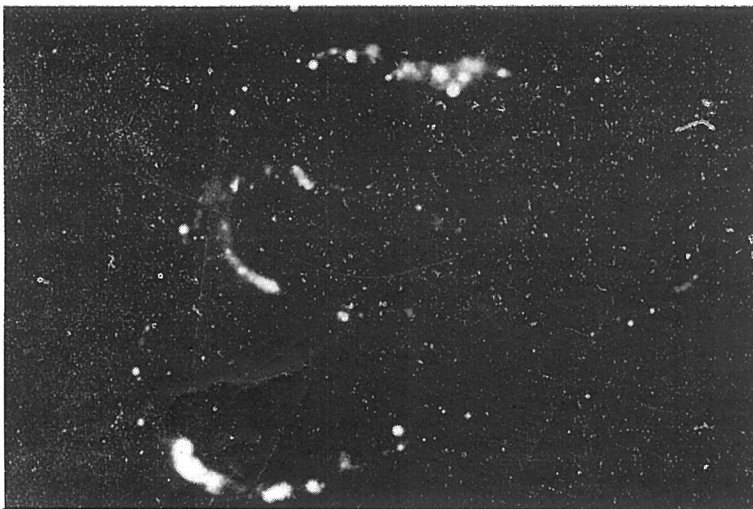
Fig. 3. Radioautograph of the hemp-palm rope.

2) Hemp-palm ropes and hemp-palm fibers used for fishing implements. Fig. 3 shows the radioautograph of a hemp-palm rope obtained from the No. 5 Fukuryu Maru. The distribution of radioactivity was not uniform. As shown in this figure points with high radioactivity and those with low radioactivity were seen alternately. In the detail radioautographs of the fibers obtained from the hemp-palm ropes and fishing implements (Figs. 4, 5, 6), small radioactive particles less than  $100\mu$  in diameter were seen attached to the fibers. The distribution of these particles was not uniform.

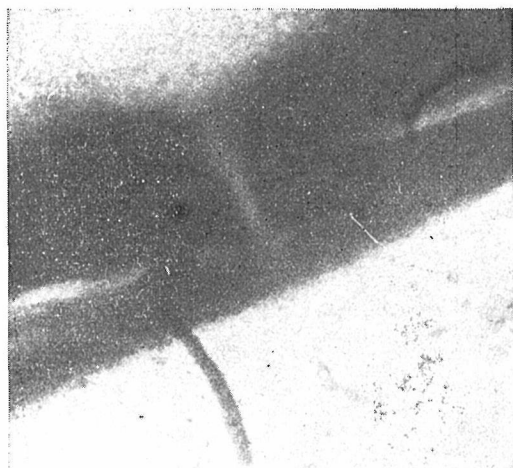
Fig. 4. Detail radioautograph of the fibers of the hemp-palm rope ( $\times 100$ ).

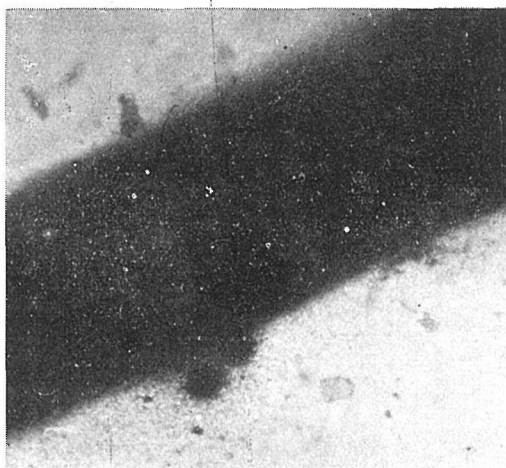
Fig. 5. Detail radioautograph of the fibers of the hemp-palm rope ( $\times 100$ ).

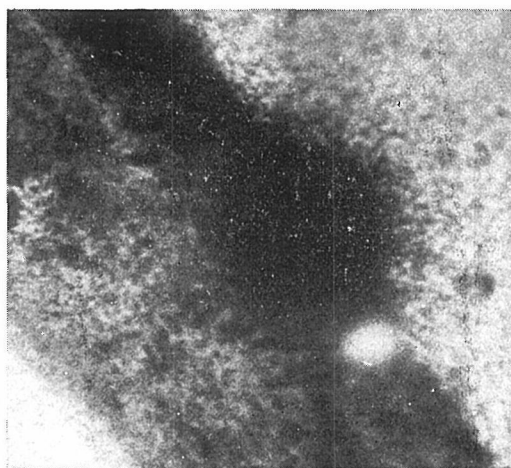
Fig. 6. Detail radioautograph of the fiber of the hemp-palm rope ( $\times 300$ ).

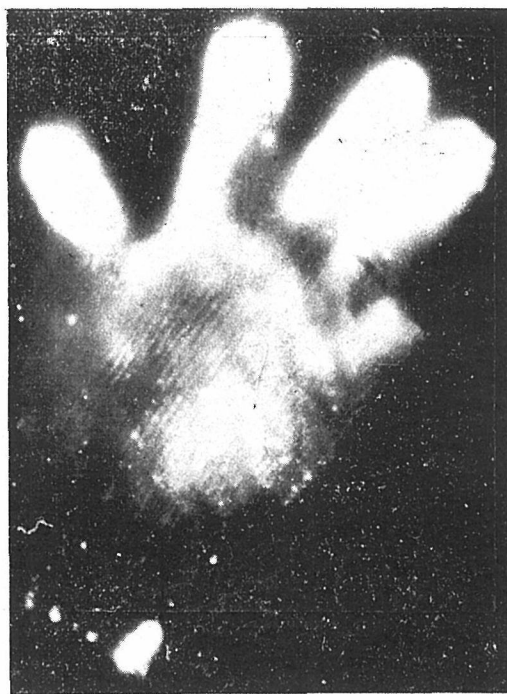
Fig. 7. Radioautograph of the glove.

3) Gloves. Fig. 7 shows the radioautograph of the gloves used by the crew of the No. 5 Fukuryu Maru. As seen in this figure, the radioactivity was marked at the tip of the fingers, especially on the palm side. The radioactivity was also pretty marked at the proximal part of the gloves. The skin lesions, which were observed at the wrist joint of the crew might be attributed to this radioactivity. In the radioautographs of the fibers obtained from the gloves small radioactive particles from 10 to  $50\mu$  in diameter were seen attached to the fibers (Figs. 8, 9). Radioactive particles larger than  $100\mu$  in diameter were not found.

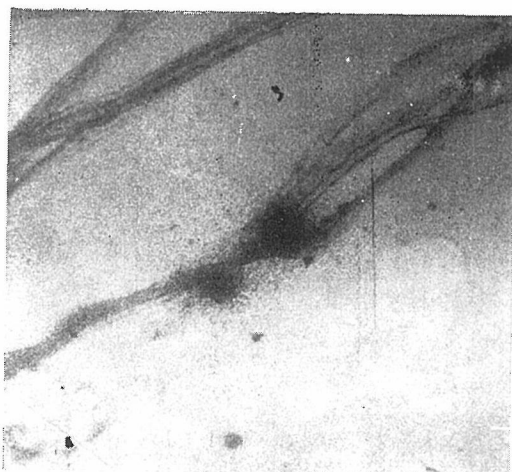
Fig. 8. Detail radioautograph of the fibers of the glove ( $\times 100$ ).

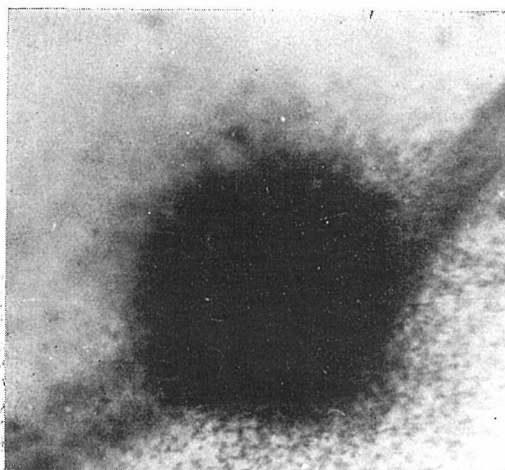
Fig. 9. Detail radioautograph of the fiber of the glove ( $\times 400$ ).

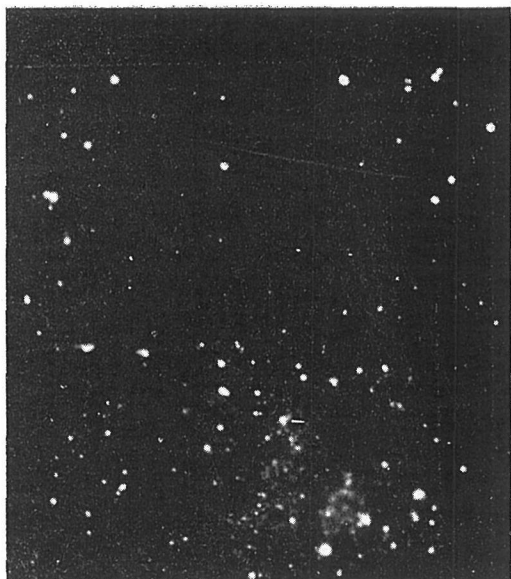
Fig. 10. Radioautograph of the side board.

5) Side boards. Pretty high radioactivity was found on the side boards, especially on their inner side (Fig. 10).

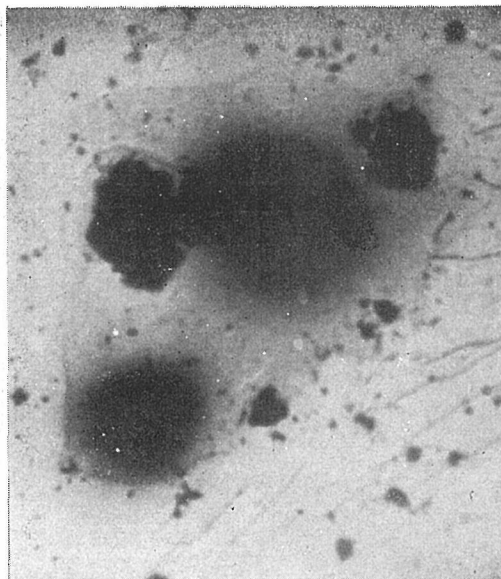
Fig. 11. Radioautograph of the dust on the deck of the No. 5 Fukuryu Maru ( $\times 100$ ).

6) Dust. In the radioautographs of the dust collected from the deck of the boat a considerable number of radioactive particles ranging from 10 to  $200\mu$  in diameter were seen (Fig. 11). Judging from the size of the particles, it was suggested that small radioactive particles would be easily scattered by the wind.
