# New Proposal for Enhancing Seismic Performance of Traditional Wooden House by Using Sheathed Wooden Lattice Walls or/and Built-Up Box-Beams

(Laboratory of Structural Function, RISH, Kyoto University)

Kohei Komatsu, Takuro Mori and Akihisa Kitamori

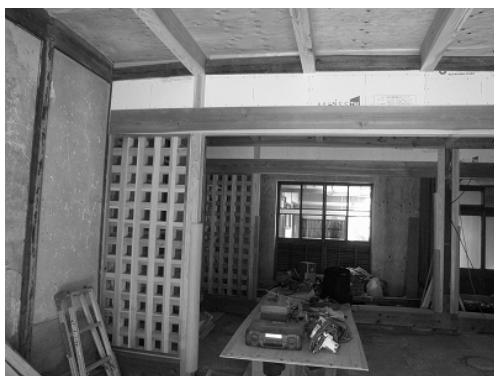
Fig.3 Inside view of the house under construction.
