## Sediment Yield and Transport on a Mountainous Small Watershed

By Kazuo ASHIDA, Tamotsu TAKAHASHI and Toyooki SAWADA

### Abstract

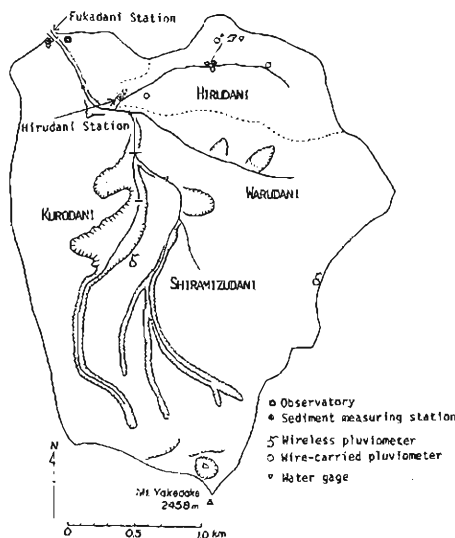
Fig. 1. Plan of watershed and arrangement of equipment for observation on the Ashiaraidani experimental watershed.

km<sup>2</sup>. This watershed is composed of four smaller basins, Kuro-dani, Shiramizu-dani, Waru-dani and Hiru-dani (Fig. 1). The drainage network over Kuro-dani and Shiramizu-dani basins originate from the gullies on the active volcano, Mt. Yakedake. Waru-dani and Hirudani drain mainly the Paleozoic strata area. Kurodani, Shiramizu-dani and Warudani have many large landslides and in these basins mud-debris flows often occur. Hirudani is, on the other hand, now in a rather stable state and in this basin mud-debris flow has never occurred since the beginning of the observation.

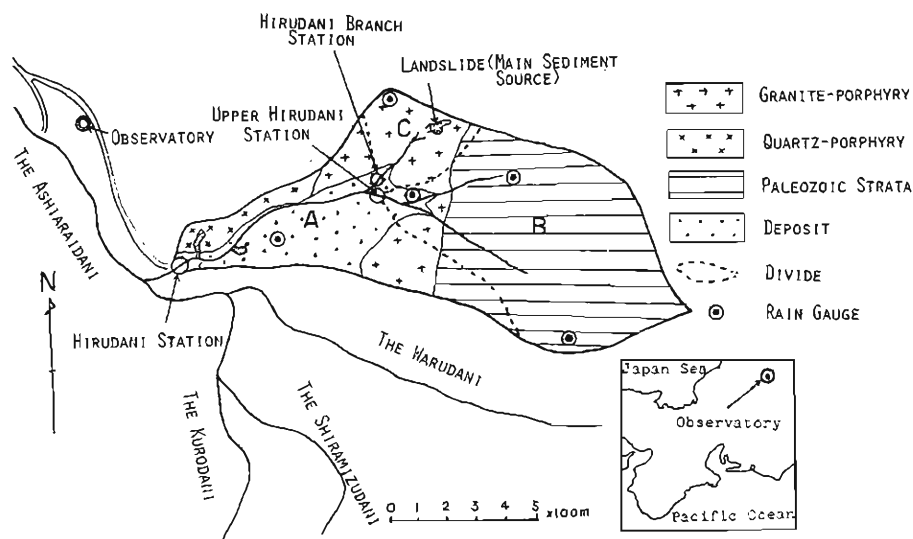
Fig. 2. Geology of Hirudani and its sub-watersheds (A, B, C).

The catchment area of Hirudani is 0.85 km<sup>2</sup>. Its altitude is 1200 m at the outlet and over 2000 m at the highest part. Geology of the watershed is, as shown in Fig. 2, Carboniferous or the Permian clay-slate in the upper part, granite-porphry in the middle part and quartz-porphry in the lower part. Terrace deposit of andesite gravel covers granite-porphry and quartz-porphry by some ten meters thickness. The main channel of Hirudani is incising the deposit layer whose infiltration capacity should be fairly good. The cover is shrub of broad-leaved trees and dense undergrowth of bamboo grass, except three very small bare slopes resulting from landslides.

From the point of view of sediment yield, Hirudani watershed can be divided into three sub-watersheds, A-, B- and C-Watershed shown in Fig. 2. Sediment sources are mainly the landslides on C- and A- Watershed. Channel erosion along the stream in A-Watershed has produced negligible sediment since the beginning of observation. Petrographical classification of yielded sediment helps the identification of the location of source. Namely, the granite-porphyry particles come from C-Watershed, the andesite particles come from either the landslide on the terrace deposit or the channel bed downstream of the junction, and the quartz-porphyry particles are produced at the landslide on the right bank of the channel near the outlet. Although the topographical inclination of the main channel downstream of the junction is about 0.2, the effective slope for sediment transportation should be much flatter due to the linking of falls and pools as is shown in Photo. 1.

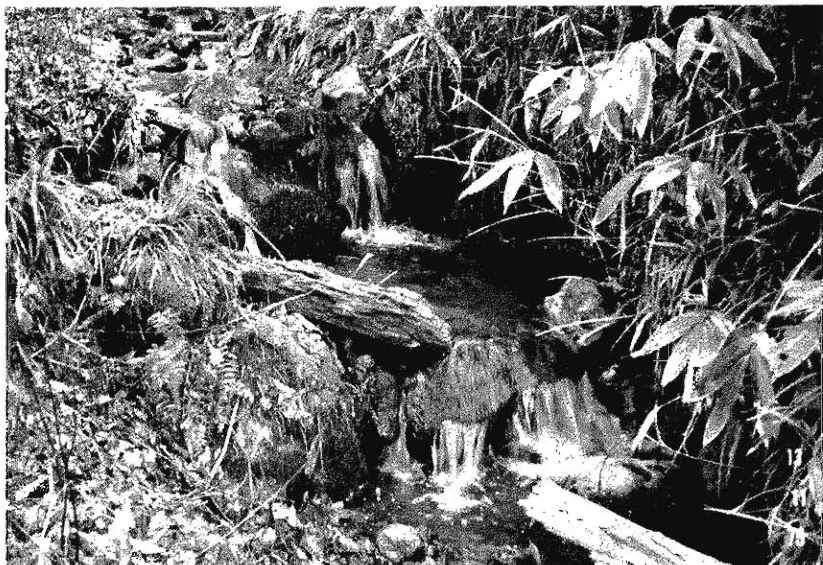
Photo. 1. Falls and pools on the Hirudani stream channel.

The stream channel is composed by linking of many pools and falls as shown in Fig. 26 and Photo. 1. The sediments are mostly deposited, as checked by field survey, at some distance downstream from the bottom of a waterfall, where the sediment to be transported covers the armoured surface and reached an equilibrium state. The slope of energy line at this part of the stream should change in relation to the flow rate from nearly horizontal in case of lower flow up to some percents in case of higher flood; notwithstanding the steep topographical inclination, the effective slope should be much flatter. Assuming a linear effective energy slope variation from 0.002 for 50 l/s to 0.01 for 400 l/s and further assuming that the breadth of the water surface obeys regime theory, i.e.  $B = 5Q^{0.5}$ , one would be able to calculate sediment discharges using, say, Meyer-Peter and Muller's equation. Cross-sections shown in Fig. 26 imply the regime theory is one reasonable approximation, at least at this flow rate. Fig. 27 shows the results of calculation and observed data. Less amount of storage than that in an equilibrium should result in smaller sediment discharge, so the equilibrium state should be in correspondence to the maximum sediment discharge under particular flow rate. The tendency of the results in Fig. 27 seems to be acceptable.

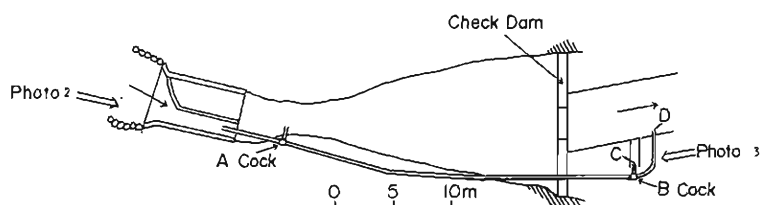
Fig. 3. Facility for the measurement of sediment discharge at Hirudani.

Here a sediment discharge measurement facility, as shown in Fig. 3, Photo. 2 and Photo. 3, is set up. This has an intake for water and sediment, whose opening is 20 cm square. This intake is fixed on a concrete flume of 1 m breadth, so that

the sediment discharges are obtained by merely multiplying the actually observed sediment discharge five times. The mixture of water and sediment, that is transported through the steel pipe from the intake comes down to cock B (Fig. 3), where the flow is switched at will to sediment trap C, a bucket made of stainless steel net, or to the by-pass D. Trapped sediment is weighed, sieved and petrographically classified by eye after drying. When the sediment discharge is low, cumulative weight variation in the sand trap is automatically measurable using a load cell. Flow rate through the trap is measured by a tank before draining.

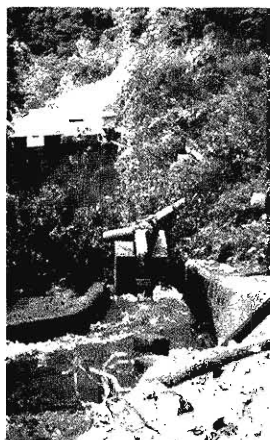
Photo. 2. A bird's-eye view of Hirudani Station.

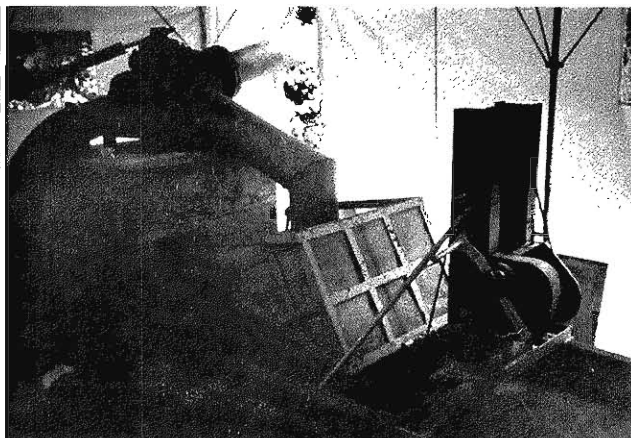
Photo. 3. Sediment sampler.

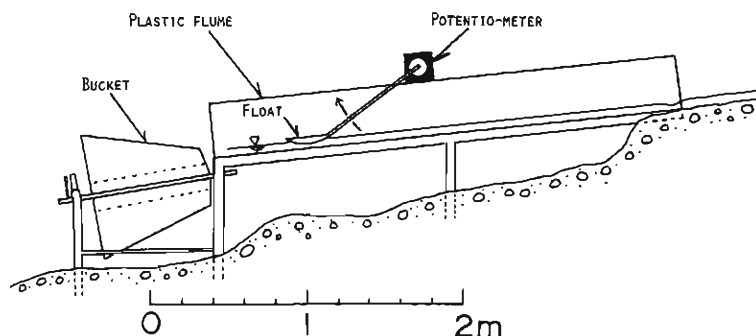
Fig. 4. Conceptual diagram of the equipment for the measurement of sediment discharge and flow rate at Hirudani Branch Station.

by using equipment shown in Fig. 4 and Photo. 4. The triangular smooth plastic flume deposits no sediment, and the water stage in it is measured by a float, which rotates the potentiometer in proportion to the stage. The 60 mesh stainless steel net bucket downstream of the flume tilts and generates an electrical pulse with each 200 grams of sediment in it. Further improvement of the equipment would be necessary, because the weight for tilting varies a little depending on the manner of accumulation of sediment in the bucket or to the extent of clogging of the sieve.

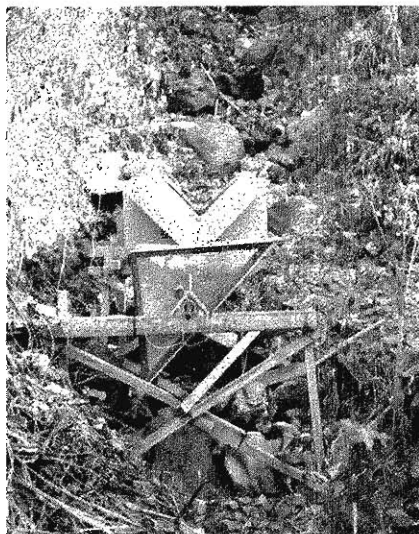
Photo. 4. The equipment at Hirudani Branch Station.

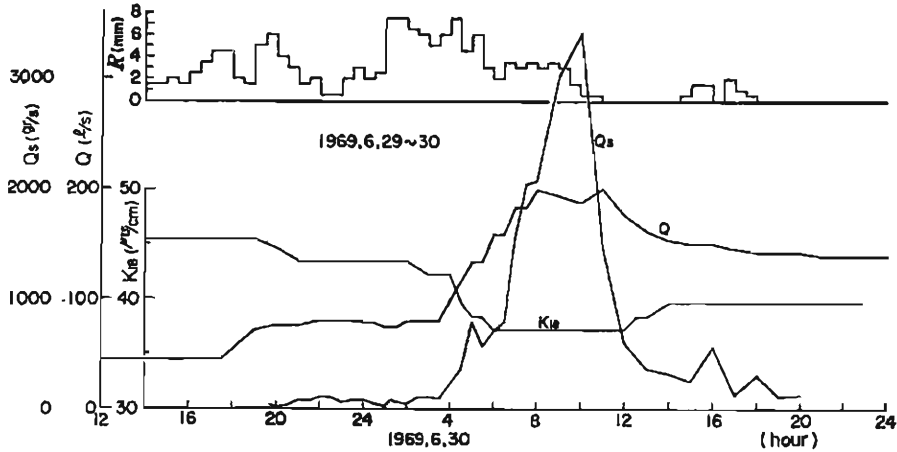
Fig. 5. 1969.6 Flood at Hirudani Station.  $R$ : rainfall (mm/30 min),  $Q$ : discharge,  $Q_s$ : sediment discharge,  $K_{18}$ : electric conductivity in water at 18°C.

- (a) Sediment discharges increase rapidly as soon as the flow rates begin to increase. After that, notwithstanding the flow rates still being large, the sediment discharge rapidly decreases.
- (b) Sediment discharge and flow rate are not in very close relation.
- (c) The calibrated electrical conductivity in flowing water decreases as the flow rate increases and recovers with the recession of the flow. It is presumably the case that the direct runoff component runs fast near the land surface and has not enough time to dissolve minerals in the ground. This characteristic might be one impor-

tant factor for the analysis of flow components. In each figure, only one rainfall record is shown, regardless that four other records were available at that time. As the analyses of spacial distributions of rainfall indicated that the rainfalls were close to uniform in respect to the total rainfall and hourly intensity, spacial uniformity has been assumed.

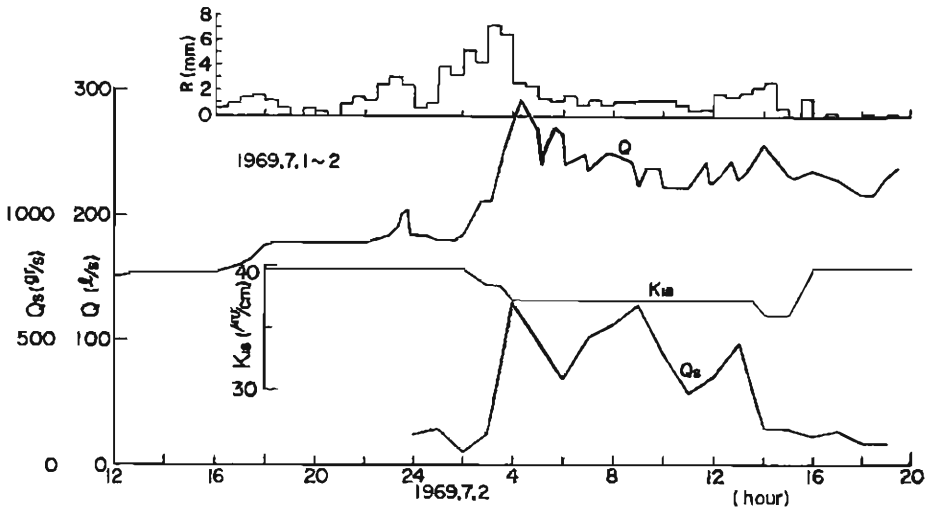
Fig. 6. 1969.7. Flood at Hirudani Station.

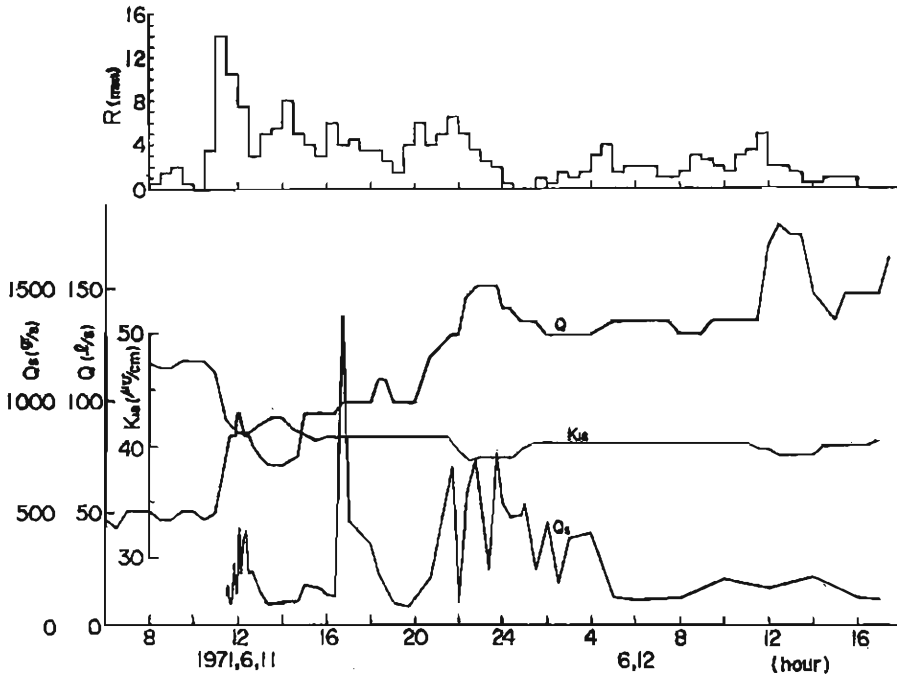
Fig. 7. 1971.6. Flood at Hirudani Station.

As was noted for the cases above, sediment discharges are high in the rising phase, but in the recession or in the less variable flow phase, sediment discharges tend to decrease, notwithstanding that the flow rates are still high. Fig. 9 shows the particle size distributions in samples collected at Hirudani Station during 1971.6 Flood.

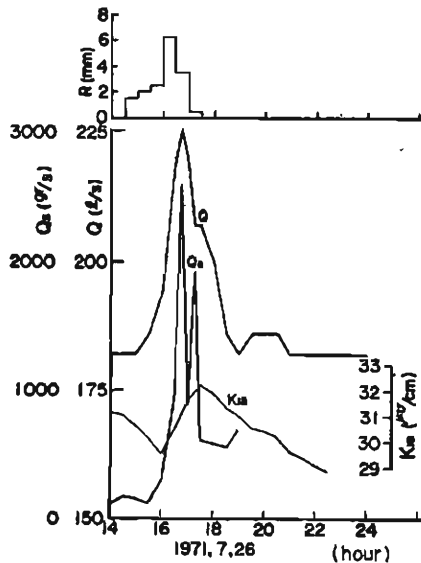
Fig. 8. 1971.7. Flood at Hirudani Station.

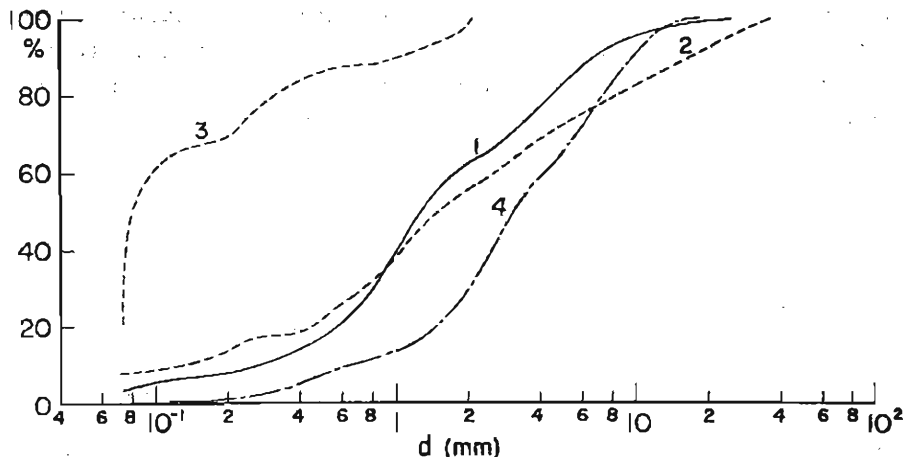
Fig. 9. Grain size distribution of the sediment:

1. Sampled at the landslide,
2. Sampled from flowing water at  $Q=152$  l/s,
3. Sampled from flowing water at  $Q=76$  l/s,
4. Sampled at the top-set bed in the reservoir.

Grain size distribution at the landslide in C-Watershed is also shown (Curve 1). Smaller size particles dominated at the early period of the rising stage (Curve 3), but afterward near the peak of flow rate, the particle size distribution (Curve 2) was very similar to the one at the source of the sediment.

Fig. 9 and Fig. 12 show that the run off of granite-porphry sediment is very similar in size distribution to that sampled at the site of production as long as the flow rate is higher than some threshold value. This implies that the tractive forces of the flow in the stream for such cases exceed the threshold value to transport the maximum size particles in produced sediment. But, if one assumes the tractive force is far beyond the threshold value and almost all sediments are transported in suspension, he should come to the conclusion that there should exist a negligible time lag, at longest ten minutes, between water flow hydrograph and the sediment discharge hydrograph. However, observed lags, as shown in Fig. 16, sometimes exceed ten hours. These results suggest the majority of sediments are transported, at least up to the flow rate of 100–150 l/s, as contact load. The cases which have practically no lag time would imply that there has been much stored sediment on the bed and side banks of the stream channel to be picked up and transported as contact load. So lag time and quantity of runoff would be affected by the antecedent storage of sediment on the stream channel. This storage should be given as a process parameter in the channel process subroutine.

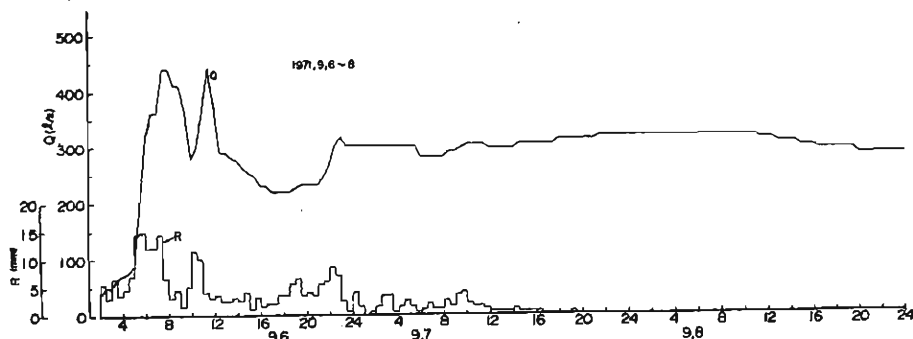
Fig. 10. 1971.9. Flood at Hirudani Station.

Sediment runoff was not measured during this flood. The flow rate was the largest since the beginning of the observation. Long after the rainfall ceased the discharge did not decrease but even increased a little. This would suggest that in this watershed the sub-surface flow component, which runs off with a lag of one or two days is very important, and the hydrograph could be the result of a composition of sub-surface flows which come out through different routes with different lag times. This characteristic could never be analyzed without dividing the whole watershed into several sub-areas from the point of view of sub-surface runoff. This would be a theme for further investigation.

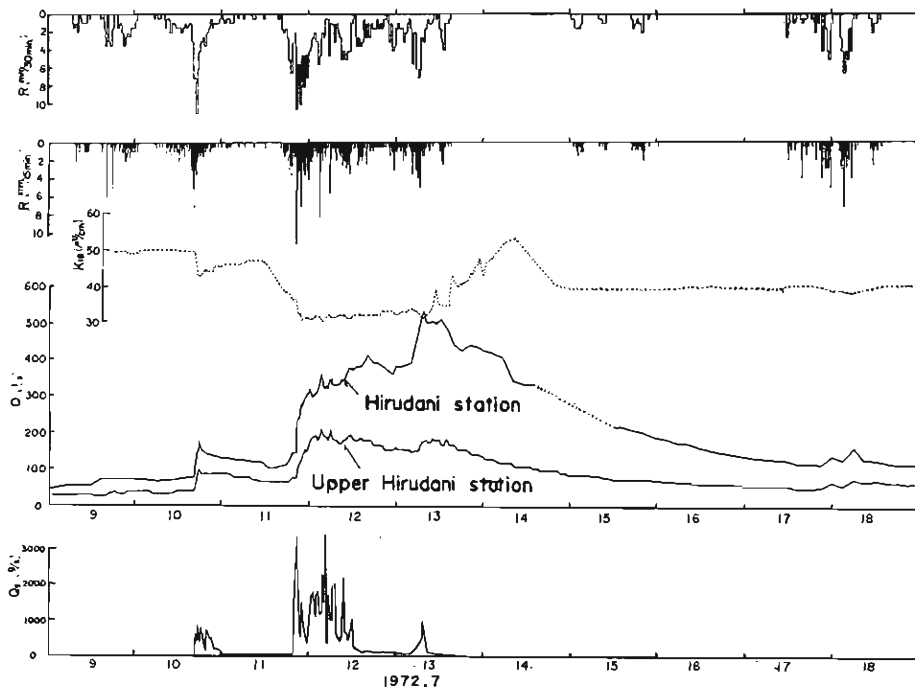
Fig. 11. 1972.7. Flood.

Two series of rainfalls caused the flood. The first one was on the 10th and the second one was from 17 o'clock of 11th July. The rainfall on the 10th was strong in intensity, but the duration was short and the flood due to this rainfall had a single peak. The hydrograph at Hirudani Station and that at Upper Hirudani Station had similar patterns.

The flood, commenced in the evening of 11th, had a maximum rainfall intensity less than that of the 10th's, but the duration was long and the peak discharge was much larger. The maximum discharge at Hirudani Station occurred during the morning of the 13th, while the maximum rainfall intensity occurred in the evening of the 11th. At Upper Hirudani Station, however, the peak discharge occurred in the early morning of the 12th. This would imply the runoff pattern of subsurface flow of A-Watershed and that of B-Watershed is different. In order to recognize the circumstances more precisely, the runoff heights from both watersheds were compared. The runoff height from A-Watershed was 253 mm and that from B-Watershed was 201 mm, whereas the total rainfall from 9th to 23rd was 438.5 mm. As was shown in Fig. 2, Upper Hirudani Station is located on the deposit, and a part of the subsurface runoff component in B-Watershed is likely to escape from measurement at the station and come out as valley springs into the stream channel of A-Watershed. This component might have come out later than the 12th and caused a delayed peak discharge at Hirudani Station.

As was noted for the cases above, sediment runoff commenced as soon as the flow rate rapidly increased, but after a while, even though the flow rate was still high, it ceased. Seeing the pattern of sediment runoff from 10th to 13th July, one might conclude that there are some close relations between sediment runoff and rainfall. The rainfall from 17th to 18th July, however, produced no sediment runoff.

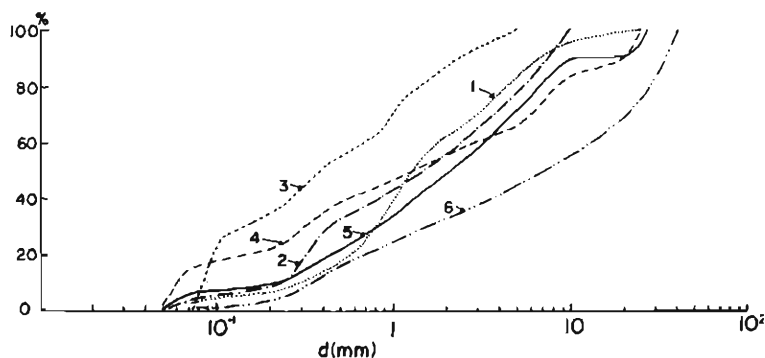
Fig. 12. Particle size distribution in the samples during the flood. 1; Sampled from the surface of landslide, 2; 11:00, 11th, July, 3; 21:00, 11th, July, 4; 21:10, 11th, July, 5; 6:10, 12th, July, 6; 22:00, 13th, July.

More detailed aspects of the phenomena were as follows:—Sediment runoff during 10th July corresponded to either rainfall or flow discharge. The majority of grain size of sediment at that time was less than 2 mm and the median diameter was 1.2 mm. Materials which run off were mostly soil and pieces of wood and grass. This is probably due to the fact that this was the first flood of the year by rainfall. The first peak of rainfall intensity for the second flood occurred between 20:30 and 21:00, 11th, July. Coinciding with the rain, the flood occurred and sediment discharge increased. Flow materials at that time were again mostly soil and pieces of wood and grass. The sediment discharge at 21:00 was up to 3300 grams per second under a flow rate of 240  $l/s$ . Then the flow rate increased up to 300  $l/s$ , but the high concentration did not last long, namely, at 23:30 the sediment discharge damped to 300 grams per second. It was when the color of water changed from dark brown to red brown and the percentage of particles larger than 2 mm increased. This should imply that the bed load had reached the station. From that time on, the sediment discharge again increased and fluctuated making a few peaks, but these peaks had no correlation with peaks in flow rates or rainfalls. After 12 o'clock of 12th, July, sediment discharge decreased to 250 grams per second, without any reduction in size of run off sediment, while the flow rate at Hirudani Station was still rising. Particle size distribution in the samples during the flood is shown in Fig. 12.

Fig. 13 shows the petrographical classification of sediment discharge for various grain-size diameters. Fig. 12 and Fig. 13 indicate that the run off sediment was mostly granite-porphry originating from the landslide on C-Watershed.

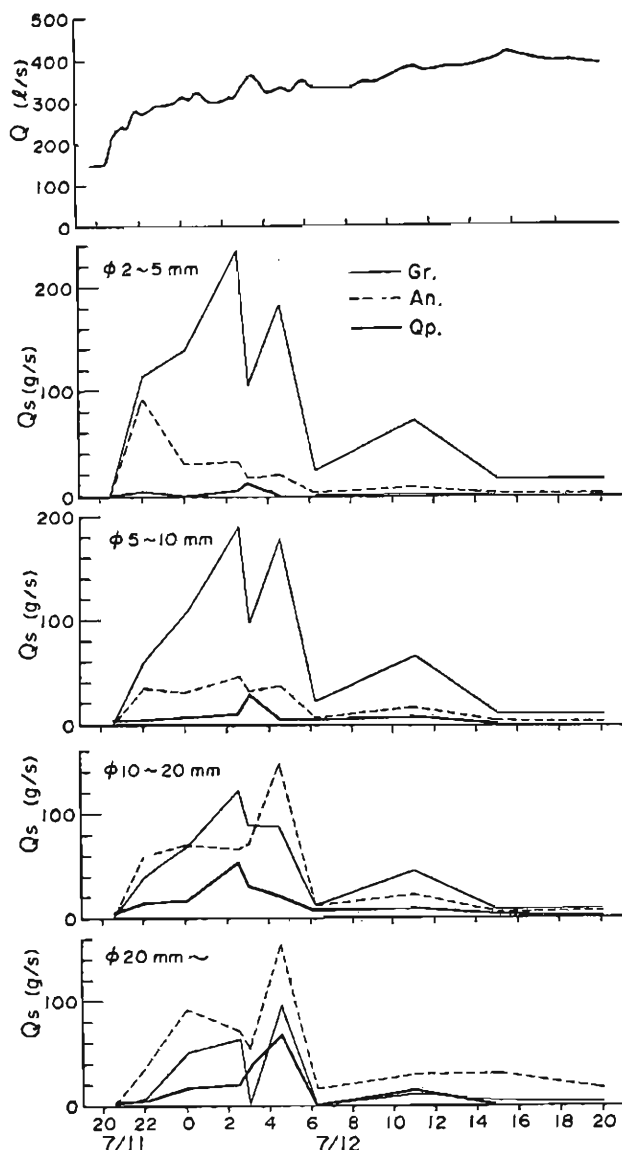
Fig. 13. Sediment discharge classified by grain size diameter and petrology.

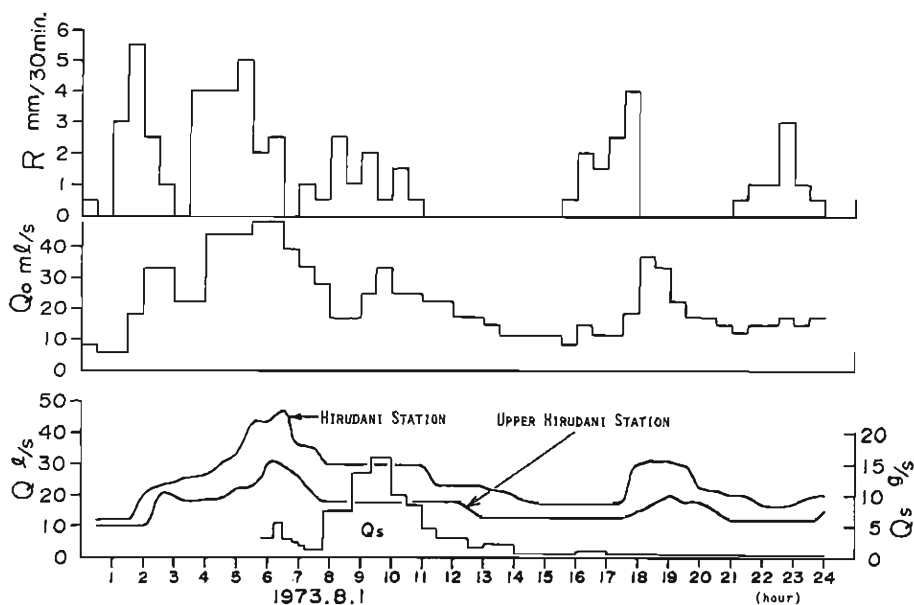
Fig. 14. 1973.8. Flood.  $Q_o$ : Spring discharge.

Rain in 1973 was very scarce. The small scale flood on the first of August was the only one occasion for observation. Measurement of the discharge from the spring at the top of the landslide on C-Watershed commenced from this year.  $Q_0$  in Fig. 14 indicates this discharge. The runoff pattern of  $Q_0$  corresponds rather well to that of rainfall, with half or one hour lag, and also resembles the hydrograph at Hirudani Station.

Turbidity in river flow began 5:30 of 1st, August. From that time on, although the volume was small, the sediment runoff occurred in correspondence to the hydrograph until 7:50 a.m.. Abruptly from 7:50 a.m., sediment discharge increased, forming a peak and then decreased, meanwhile the flow rate was almost constant. From 17:30, the flow rate again increased, but the sediment runoff no longer in-

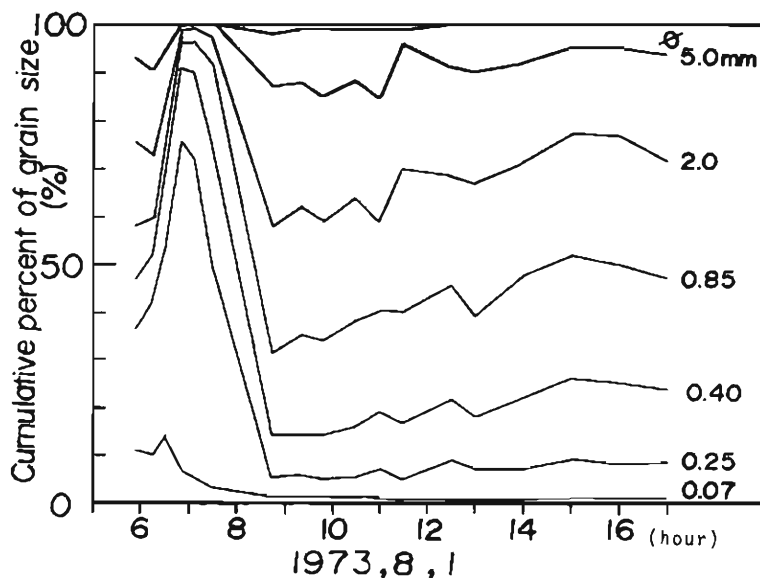
Fig. 15. Variations in grain size distribution of the sediment during the flood.

creased. Sediment particle size distribution varied during the flood as shown in Fig. 15. Sediments sampled from 6 to 8 o'clock had far smaller size than that at the place of production, which is 2 mm in median size. After 9 o'clock, however, the sediment particle size distribution resembled that at the place of production. This fact would imply that the manner of transportation of sediment between the early stage and later had been different; as suspension in the former and as bed load in the latter. Although the sediment size distribution is similar to the one at the landslide of granite-porphry, petrographical classification of sediment revealed the majority of run off sediment was andesite.

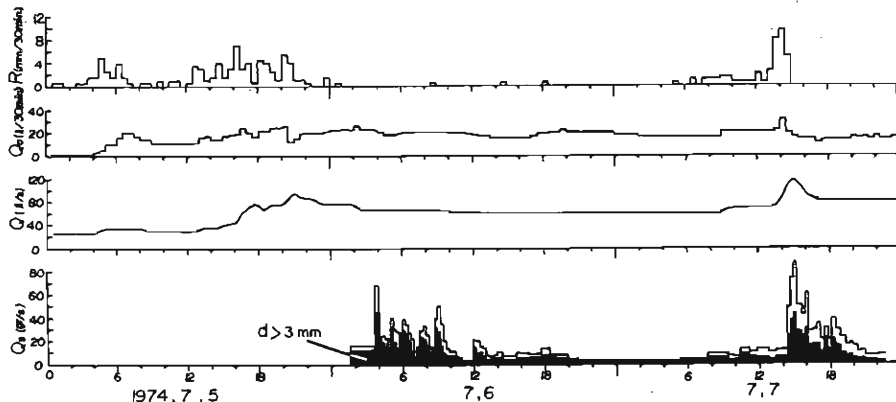
Fig. 16. 1974.7. Floods.

For the case of the first flood, turbidity in the flowing water began to be observed with the beginning of rise in flow rate, but the measurable amount of sediment reached the station about ten hours later. On the other hand, for the case of the second flood, the peak of sediment discharge well corresponded to the peak of flow rate. This was the first time such a long lag between hydrograph and sediment runoff had been observed. Eighty to ninety percent of the run off sediment was granite-porphry and the andesite, which was very scarcely distributed along the stream channel. This would mean that the sediment was mostly transported from C-Watershed. In this flood sediment particle sizes were rather large and about 80 percent of them were larger than 3 mm. Remarkable fluctuation in sediment discharge under constant flow rate is another characteristic of this flood.

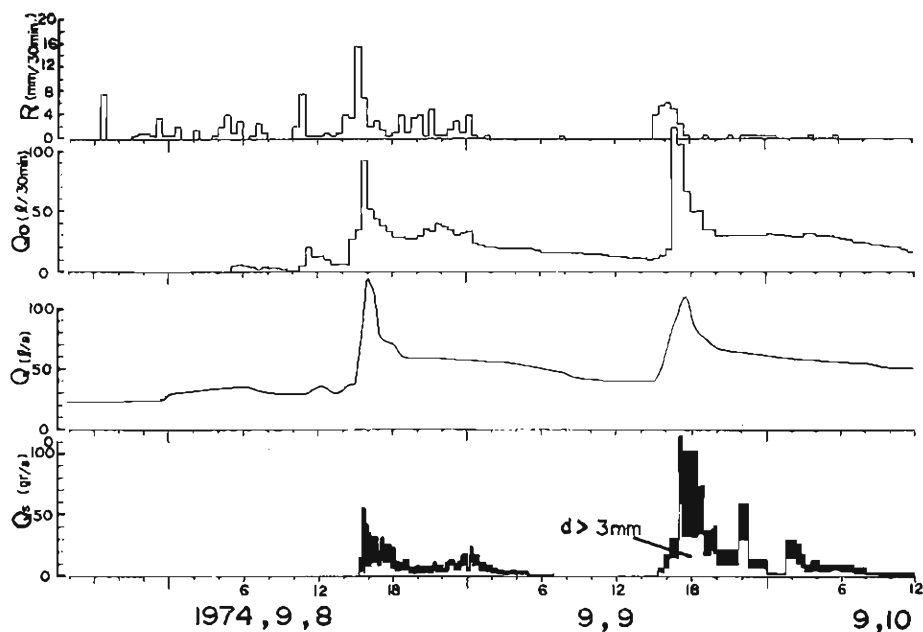
Fig. 17. 1974.9. Floods.

These flood happened following the flood described above. Sediment runoff in these floods well corresponded to the flow rate. Petrologically, the sediment was, as the previous floods, mostly granite-porphry, but its size was finer than previously.

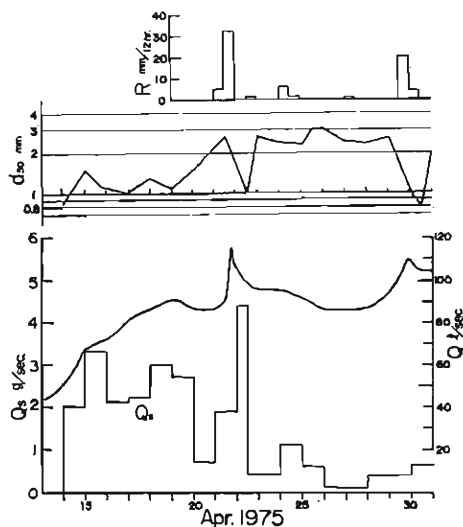
Fig. 18. 1795.4. Flood due to snow melting.

Flow rate due to snow melting is large in this watershed. Since the duration time of snow melting flood is long, it plays a very important role in sediment runoff phenomena. Fig. 18 shows one example of snow melting flood. Similar to the flood due to heavy rainfall, sediment runoff concentrated in the first stage of the flood

and then gradually tapered. Rain fell on 21st April and the flow rate increased a short while later. The peak of sediment runoff appeared twelve hours after the occurrence of the flow rate's peak. These circumstances resembled those of the 1974.7.6 Flood.

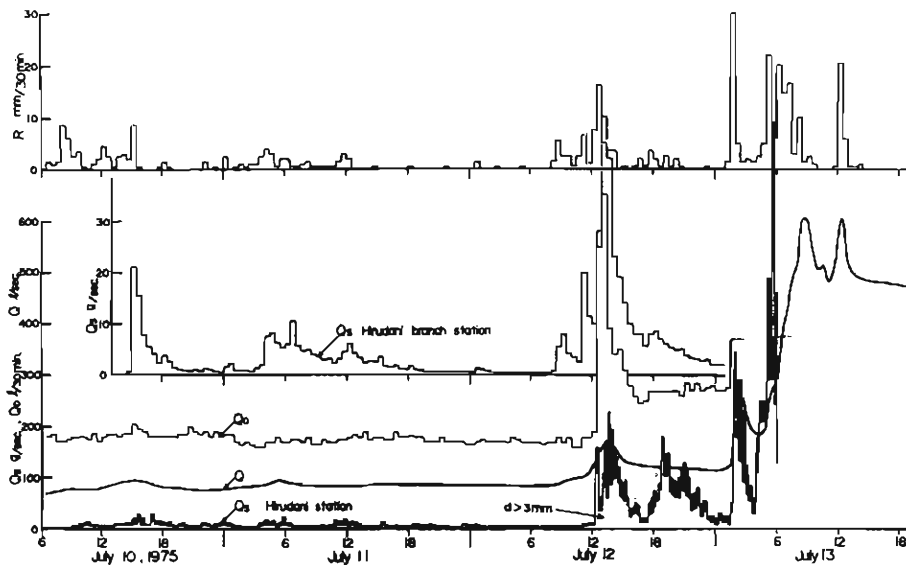
Fig. 19. 1975.7. Flood.

In the cases of 1975.4 Flood, 1974.7 Flood and 1974.9 Flood, sediment runoff occurred when the flow rate exceeded 50 l/s. Although the flow rate reached 81 l/s on 4th, July, 1975, no sediment runoff was observed. From 8th July small amount of sediment discharge was being observed when, suddenly, on 12th July considerable sediment runoff appeared. A series of sediment runoffs which had a peak of 230 grams per second, of which occurrence time was coinciding to that of flow peak of 160 l/s, damped out to 20 grams per second before 17 o'clock on the 12th. After that, the sediment discharge, which had a similar runoff pattern and was equivalent in peak sediment discharge to the former one, was again observed under nearly constant flow rate. Sediment discharge at Hirudani Branch Station has been observed since this year. At this station, as is shown in Fig. 19, the sediment discharge hydrograph corresponded well to the hyetograph or spring discharge hydrograph, having only one peak during 12 to 24 o'clock of 12th July. So the double peaked sediment runoff at Hirudani Station should have its cause in the process of stream channel downstream of the junction. It might be due to the stream channel variation. On the 13th July, the sediment discharge hydrograph seemed to correspond to the flow rate variation, but unfortunately, after 6 o'clock, sediment discharge measurement became impossible due to clogging of the intake of the sampler.

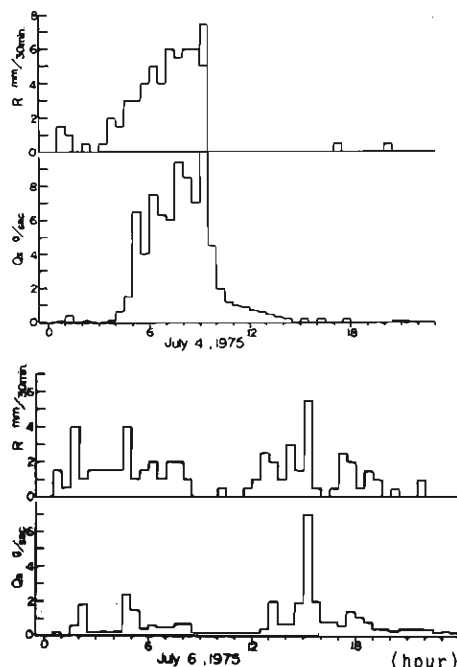
Fig. 20. Rainfall and sediment discharge at Hirudani Branch Station.

Other examples of sediment runoff measurement at Hirudani Branch Station are shown in Fig. 20. Here, it seems to be close relation between sediment discharge and rainfall. This implies that as soon as rain stops, sediment supply from C-Watershed would also stop. On the other hand, discharge from B-Watershed would continue long after that and would be able to transport the sediment sweeping, occasionally scouring the channel bed and banks downstream of the junction.

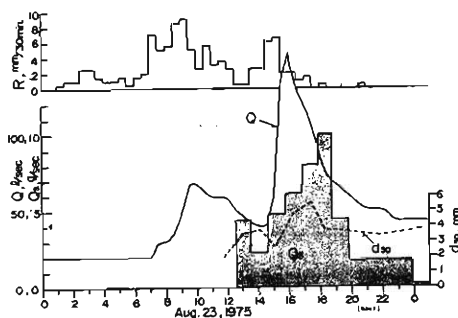
Fig. 21. 1975.8, Flood.

Since the flood in July was very high, there was severe scouring of stream channels. The flood shown in Fig. 21 was the first to occur after the July flood. Sediment

runoff was observed at Hirudani Station from 5.5 hours after the beginning of rise of flow or 3 hours later than the time of flow peak. The transported sediment during this flood was mostly andesite gravel whose median diameter was 3 to 5 mm. The source of supply of andesite gravels is located at about 150 m upstream of Hirudani Station. This is a land slide on the margin of the terrace deposit. Fig. 21 shows that the andesite gravels were transported for a length of 150 m in three hours, corresponding to the average velocity of 1.4 cm/s.

was measured by multiplication of the storing area by the accumulation thickness, where the thickness was measured by penetrating a steel bar of 2 cm in diameter. Since the bar could not penetrate through the cobble (larger than 10 cm in diameter) coated bed, simply the thickness of accumulation of sand and gravel was rather accurately measured. One can see, in Fig. 25, the sediment deposited on the channel bed and banks at the end of October, 1973, had been thoroughly swept off by the spring floods. Accordingly, little storage of sediment was available in June 1974, and so the antecedent storage for the first flood of the year due to rainfall (1974.7.5 Flood), was practically zero. For this case, the capacity of transportation was larger than supply, but was not large enough to destroy the armoured channel bed. Sediment supply from Hirudani Branch Station should have begun as soon as the flood occurred, because the channel reach upstream of the station always stores the sediment. Supplied at the junction, the sediment should have traveled the coated bed through many falls and pools taking about ten hours. The distance from the junction to the mouth (Hirudani Station) being 600 m, the velocity of the sediment particles was about 1.8 cm/s. This is the same order of velocity as the case of 1975.8 Flood (Fig. 21).

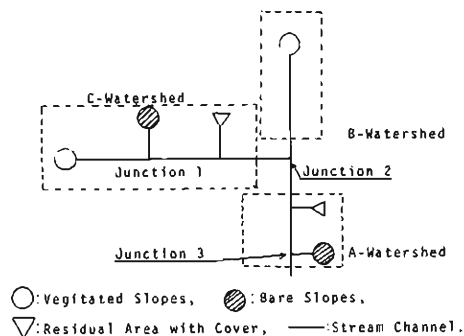
Fig. 22. Schematic representation of Hirudani watershed.

An alternative approach to a more universal prediction would need a conceptual modeling of the phenomena on the watershed. In developing the structure of the model, the component processes would be identified and linked as a flow chart. Theories representing the component processes do not exist yet in forms ready to be used. The authors believe that investigations on the mechanism of transportation and deposition along the stream channel should be as important as the investigations on the producing mechanism on the surfaces of slopes. This should be especially so, if the produced sediment particle sizes are large and they are mostly

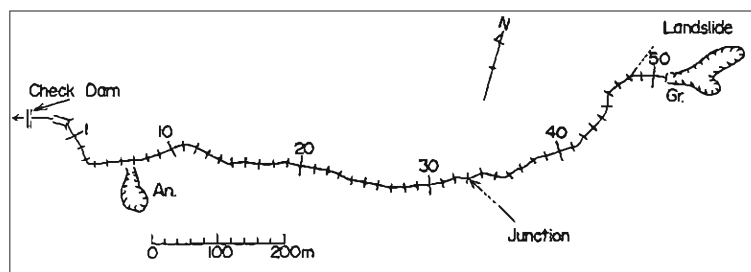
Fig. 24. Plan of the Hirudani channel course and its surveying marks.

In order to estimate the order of variation of antecedent storage of sediment, field surveys of storage volume for every 20 m in the reach shown in Fig. 24 have been done. The results are shown in Fig. 25. The volume of sediment in each section

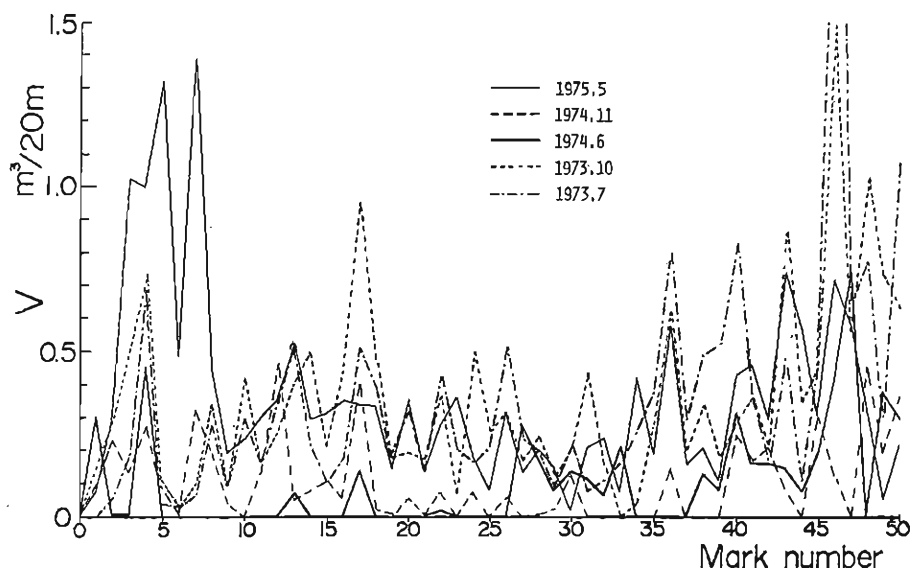
Fig. 25. Sediment storage variation for every 20 m on the course of the Hirudani stream channel.

Fig. 25 also shows the average sediment storage used to amount 0.3 or 0.4 m<sup>3</sup> per each 20 m reach. This suggests that the sediment transportation approaches a sort of equilibrium state under this amount of storage. Allowed this conjecture, the flow rates and sediment discharges should be closely related to each other under

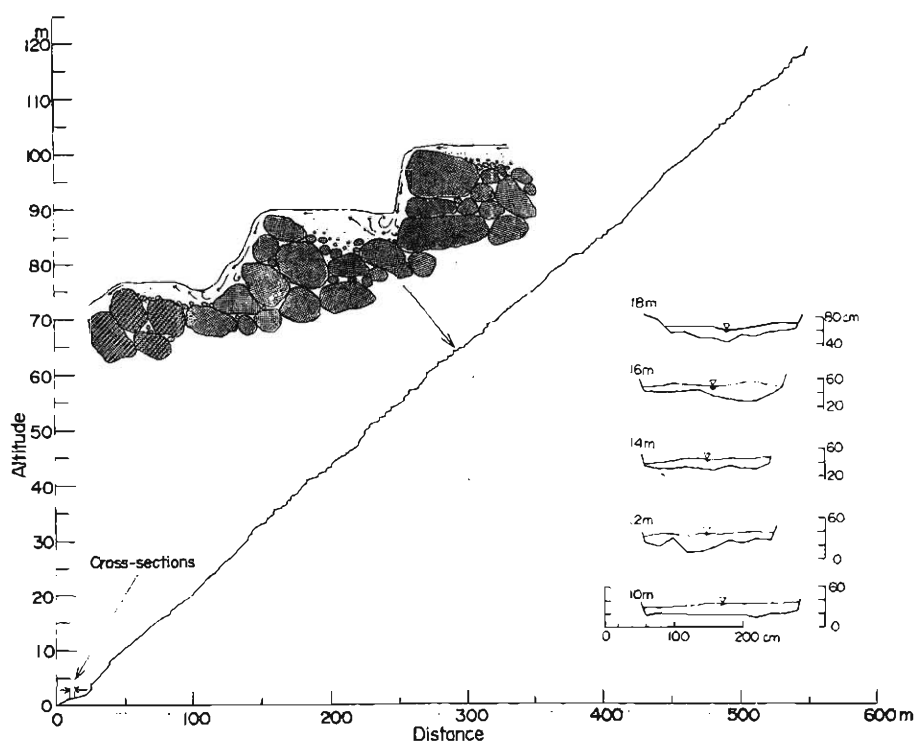
Fig. 26. Longitudinal profile and some representative cross-sections in the Hirudani.

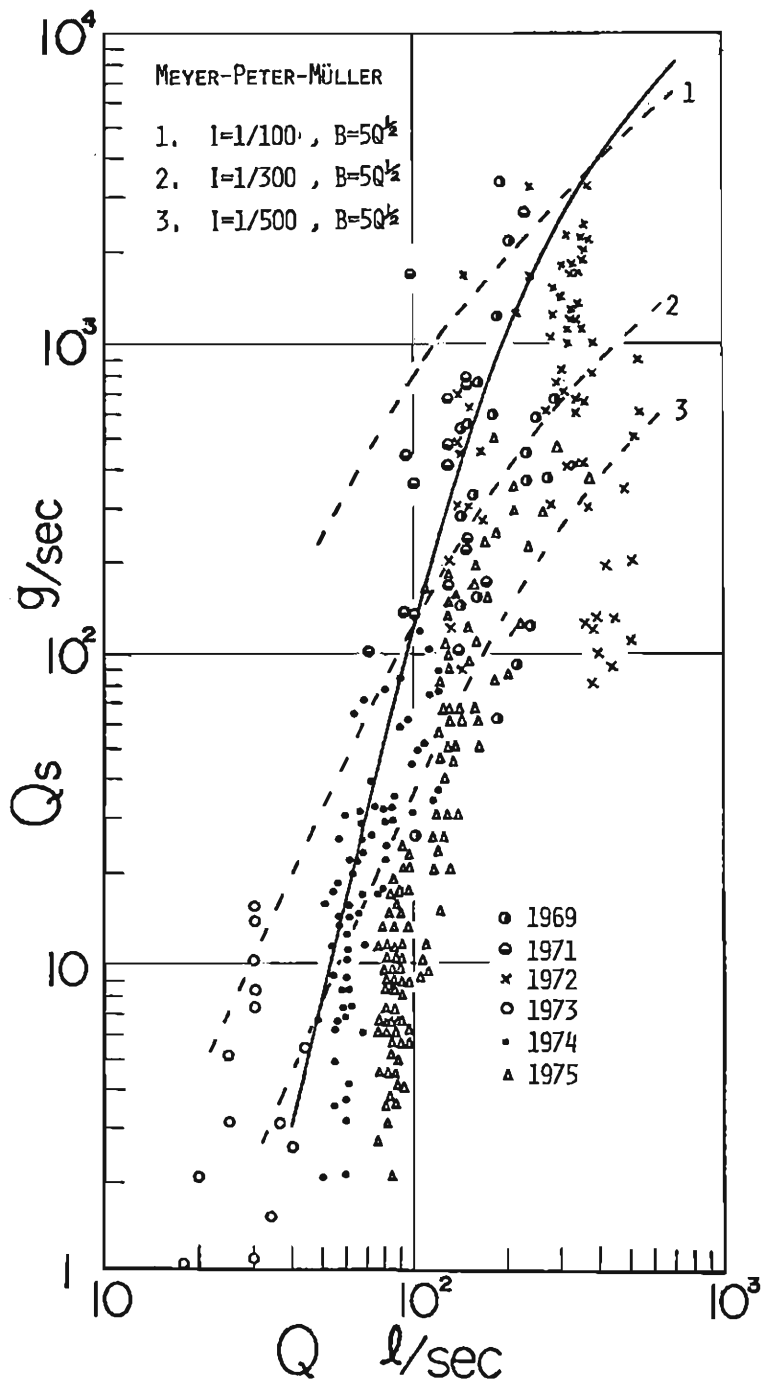
Fig. 27. Relation between flow rates and sediment discharges on the Hirudani.
