# Estimation Method for Roof-damaged Buildings from Aero-Photo Images During Earthquakes Using Deep Learning

Shono Fujita<sup>1</sup> · Michinori Hatayama<sup>2</sup>

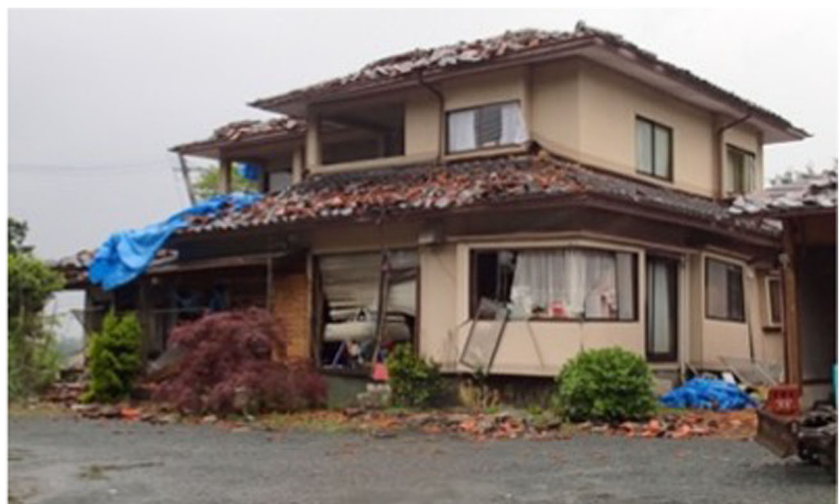
**Fig. 2** A building whose roof is damaged

Currently, observing the damage from the outside is the only way to investigate the damage level of the roofs. This method of investigation is difficult and has low accuracy of evaluation in the investigation of the building like Fig. 2.

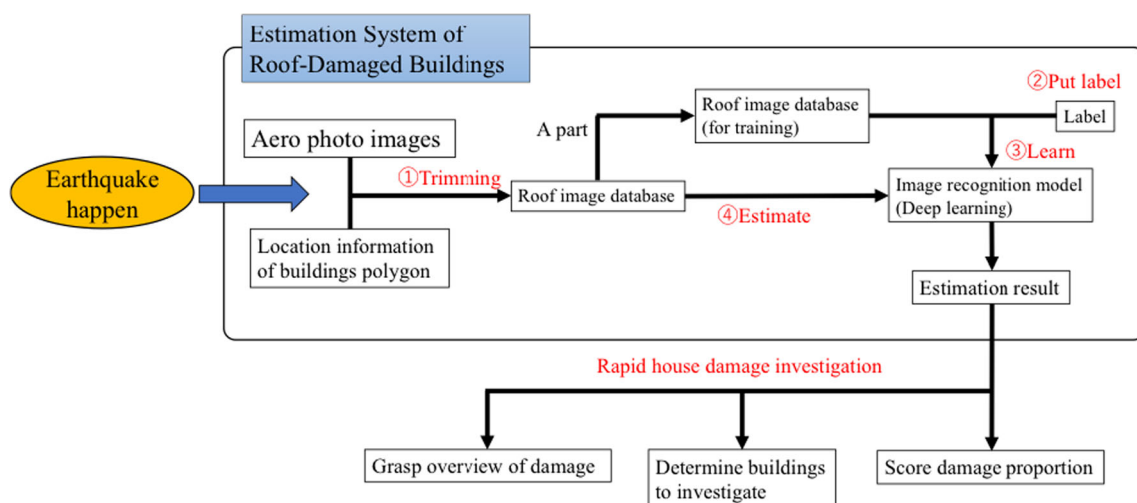
Fig. 3 Structure of the proposed system

Figure 3 shows the structure of the system in this study. First, the system performs the trimming algorithm from aero-photo images and locates information on building polygons in GIS to make a roof-image database. Considering the

characteristics of a roof damage in an area, a part of the roof-image database is used for deep learning training data. Second, each label, whether the roof is damaged or not, is put to each image in the training data manually. This system uses supervised learning as image recognition model. Next, the system makes a DCNN model learn feature of damage roofs from the roof-image database and the label for training. Finally, the system enables the DCNN model to estimate damaged roofs from the remaining database and also estimate damaged buildings.

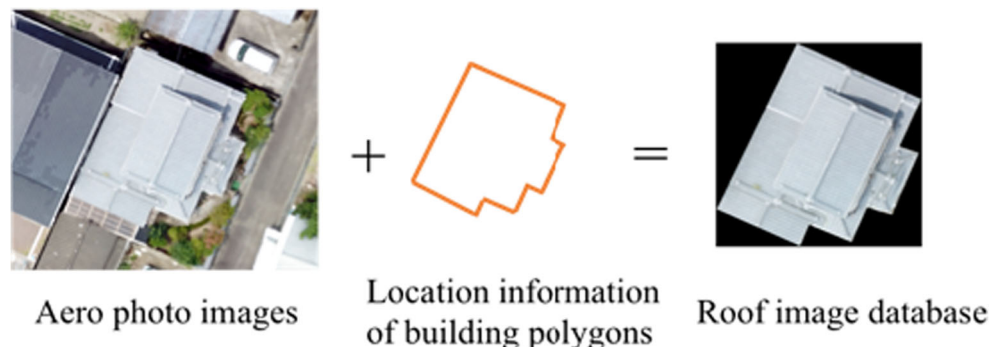
**Fig. 4** Trimming algorithm

First, the algorithm obtains both maximum and minimum values of longitude and latitude of the building polygon vertex from GIS and makes a circumscribed quadrangle. Next, the algorithm determines whether each pixel in the circumscribed quadrangle is in the building polygon. This judgement can be understood from counting crossing points of building polygon lines and lines drawn from the target point to the right end point like Fig. 5. If the number of cross points is even, the target point is out of the building polygon. In contrast, if the number is odd, the target point is inside the building polygon. This algorithm paints pixels outside building polygons with black and pixels inside with the color as it is.

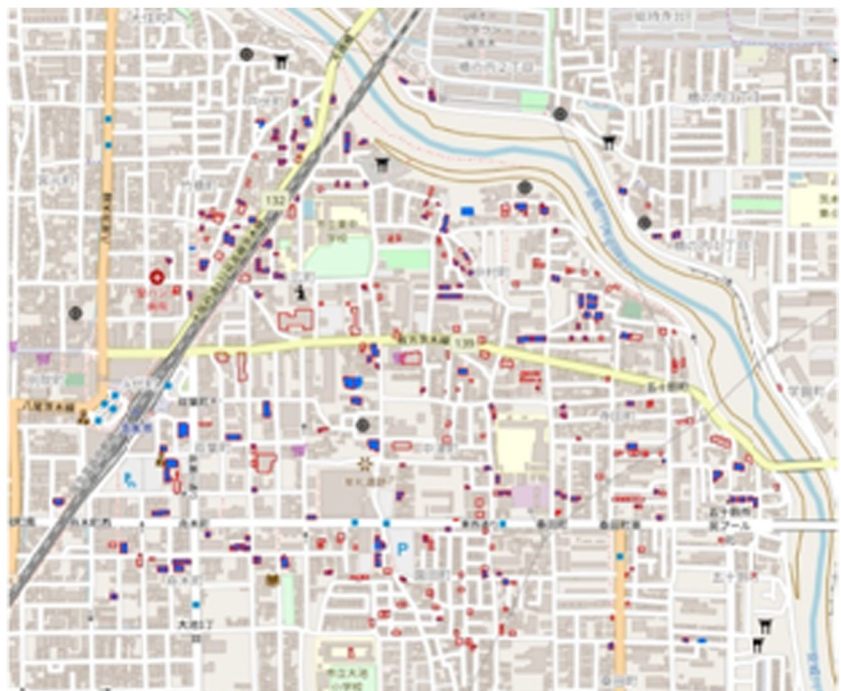
**Fig. 9** Map visualizing estimation result on map (blue paint: actual blue sheet; red frame: estimated blue sheet)

capable of estimating the buildings that needed investigation and also reduce the number of investigations efficiently, although the accuracy of estimation for direct damage may decrease. However, if the target area has more undamaged buildings than damaged ones, the system was found to overestimate damaged buildings. In the future work, we must consider the reduction of the overestimation to make the system more practical. Additionally, in both these applications, we must not only consider the damaged roofs of buildings but also other damaged parts. Furthermore, considering that these damaged buildings could not be detected by our system, we must use information of other investigations, such as quick post-earthquake inspections of damaged buildings or other estimation methods. Moreover, local governments can use map visualizing estimation result to make an efficient investigation plan.

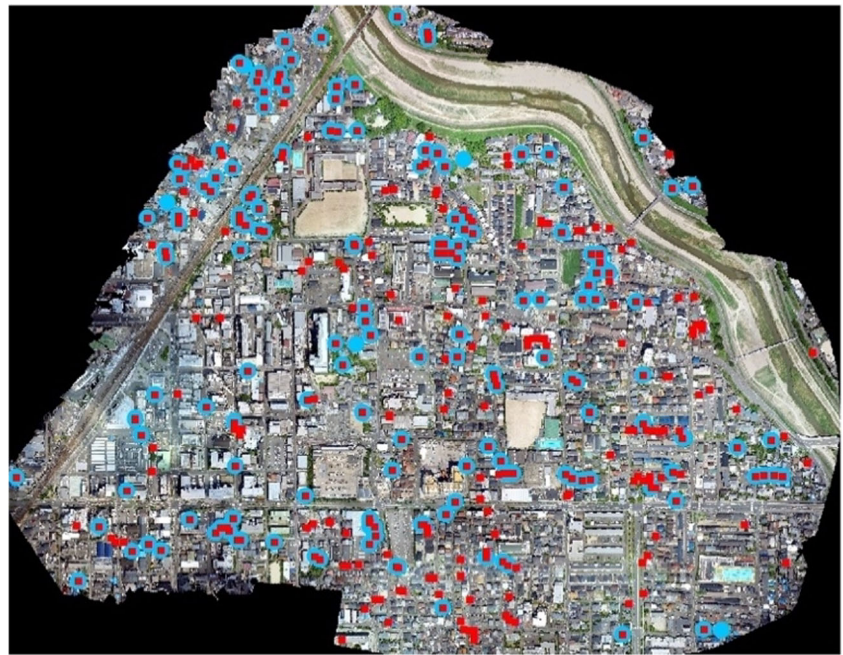
**Fig. 10** Map visualizing estimation result on aero photo (blue point: actual blue sheet; red point: estimated blue sheet)
