# Landslide problems along Highway of Central Vietnam

Do Ngoc Ha, Fawu Wang, Kyoji Sassa

Kyoto, 07<sup>th</sup> October 2012

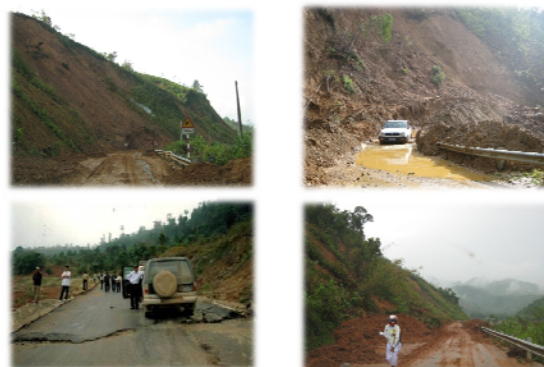
Landslide along Ho Chi Minh National Highway

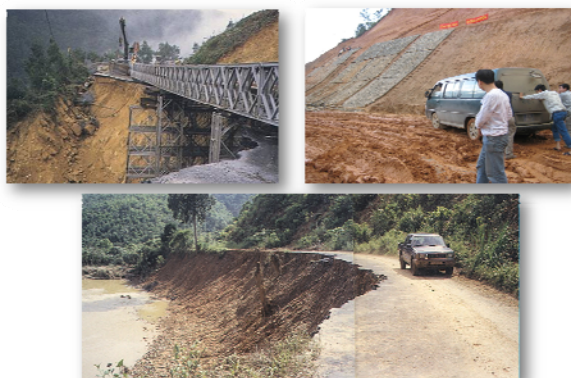
Landslide along Ho Chi Minh National Highway

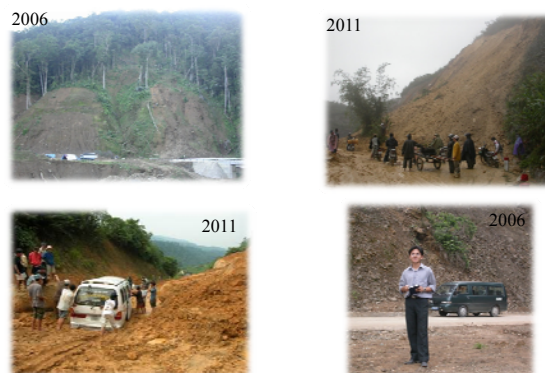
Landslide in Ho Chi Minh National Highway, Km399T+000

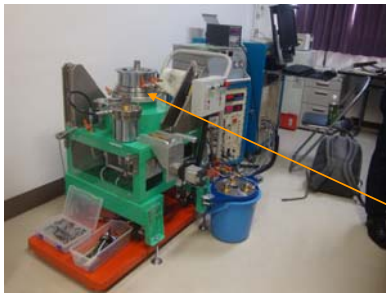
Shear ring test apparatus will be in Vietnam

- Data collection of rainfall and geological structures in Central Vietnam;
- Laboratory test using portable dynamic undrained ring shear apparatus and direct shear apparatus;
- Model test with different rainfall intensity and geological structures in laboratory;
- Numerical simulation.

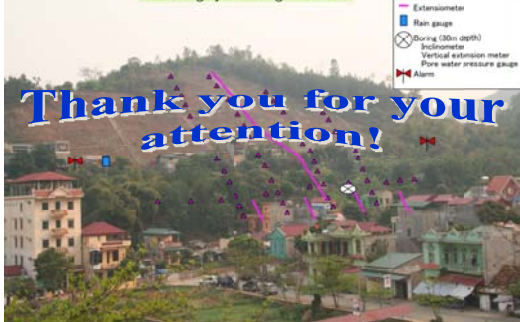
Monitoring system image in Son La

- ▲ Prism
- Extensometer
- Rain gauge
- ⊗ Boring (30m depth)
- ⊕ Inclinometer
- ⊙ Vertical extension meter
- ⊕ Pore water pressure gauge
- ⚠ Alarm

Monitoring system will be in Vietnam
