## Hazards from Surface Faulting in Earthquakes

By Yoshimasa KOBAYASHI

### Abstract

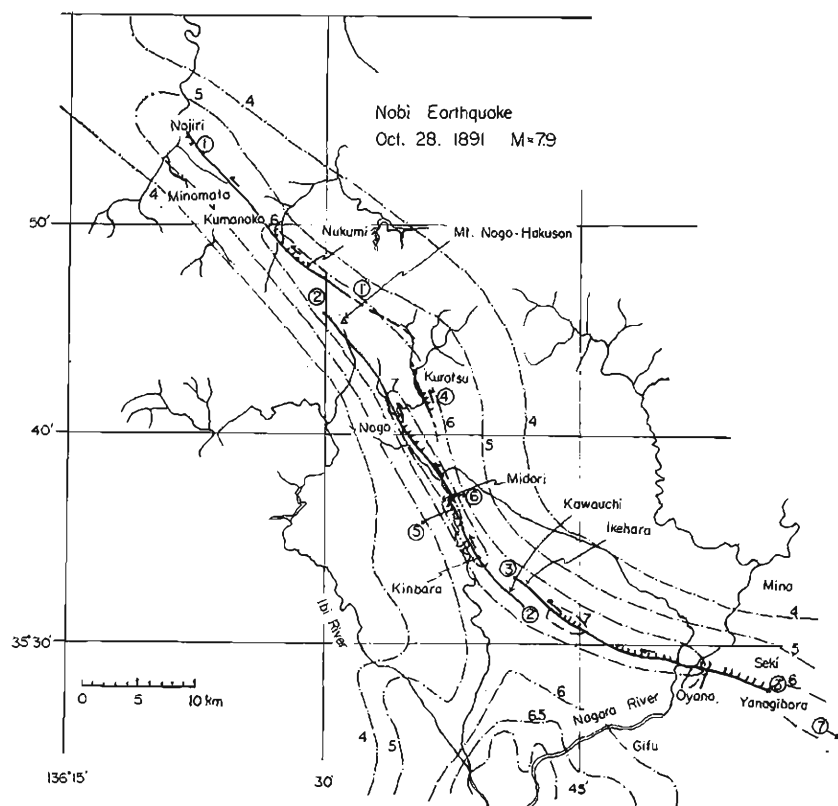
Fig. 1. Faults and earthquake intensities in the Nobi earthquake; ①; Nukumi fault, ②; Neodani fault, ③; Umehara fault, ④; Kurotsu fault, ⑤; Midori fault, ⑥; Midori-Daishogun fault, and ⑦; Koze fault. (compiled after Matsuda and Muramatsu)

**Nobi Earthquake in 1891;** Faulting in the Nobi earthquake is described by Matsuda<sup>5)</sup> in detail. The main fault segments from north to south are the Nukumi fault of about 20 km from Nojiri to the Nukumi pass, the Neodani fault of about 35 km from the south of Mt. Hakusan to the east of Kawauchi, and the Umehara fault of about 25 km from the north of Ikehara to Yanagibora, which formed an aggregated main fault system of about 80 km long with a trend of NW-SE. Besides the above, several faults of shorter extension as the Kurotsu, Midori, Midori-Daishogun, and Koze faults exist (Fig. 1).

In Fig. 1 it may be noted at once that the three main fault segments do not constitute a simply connected line, but there are gaps of about 3 km and 1.5 km between the ends of the Nukumi fault, the Neodani fault, and the Umehara fault in turn, and also that the mean strike of the main fault line changes from N45°W in the northern part to N60°W in the southeastern Umehara fault. Nasu<sup>6)</sup> estimated a hidden, i.e. sub-surface fault named Line C based on the result of levelling at triangular points. Muramatsu<sup>7)</sup> also suggests a concealed fault line from Kinbara through north Gifu and Ichinomiya to Nagoya on the basis of data of seismic intensity and crustal deformation, which line deflects to some extent eastward from the line C.

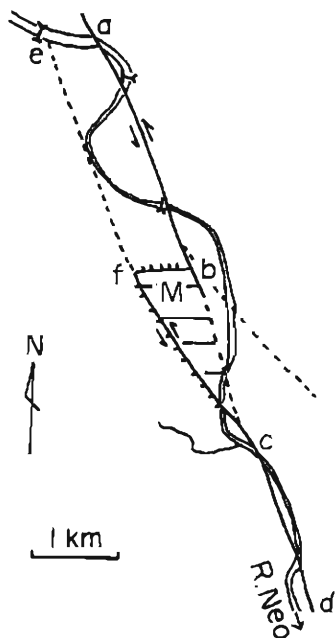
Fig. 2. Triangular bulge at Midori due to left-lateral movement on the main fault in the Nobi earthquake; a-b-c-d; Neodani fault, e-f-c; Midori fault, and b-f; Midori-Daishogun fault. (illustrated after Matsuda)

the Midori fault with 4.0 m(H), where in contrast to cases in most of the main fault segments the NE side was uplifted. This peculiar phenomenon may be attributed to a bulging due to compression accompanying the left lateral shear of a triangular block bounded by the Midori fault (N40W), the Midori-Daishogun fault (nearly EW) and the main fault of Neodani<sup>5)</sup> (Fig. 2).

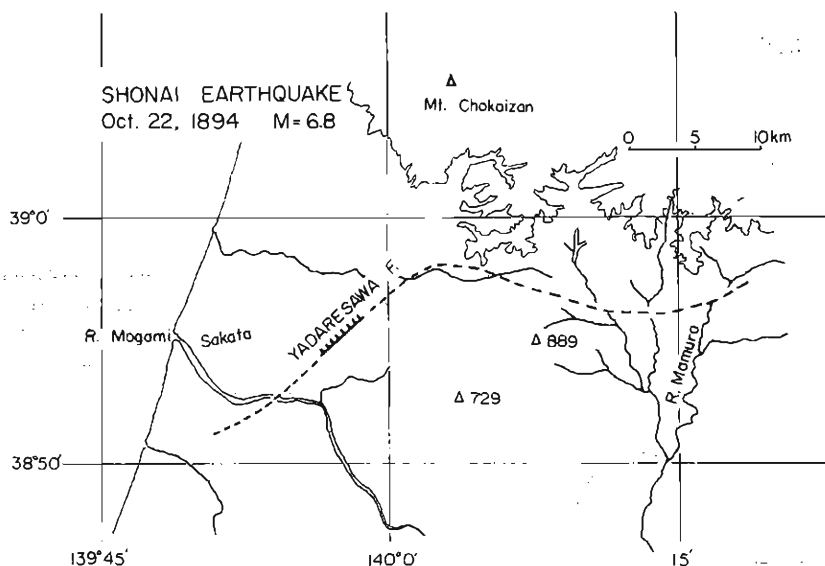
Fig. 3. Faulting in the Shonai earthquake. The broken line is postulated.

The above concealed part to the west and the postulated part for the more easterly region than Aosawa on the basis of a report on the damage by Sugaya are drawn in broken line in Fig. 3. In Table 1 the length of the Yadaresawa fault is given as 10-km, which corresponds to the part from Nibori to Kita-Aosawa. In conclusion it seems to be doubtful if faulting actually occurred in the Shonai earthquake, or at least it must be stated that not much is known so far on the faulting in this earthquake in view of available materials.

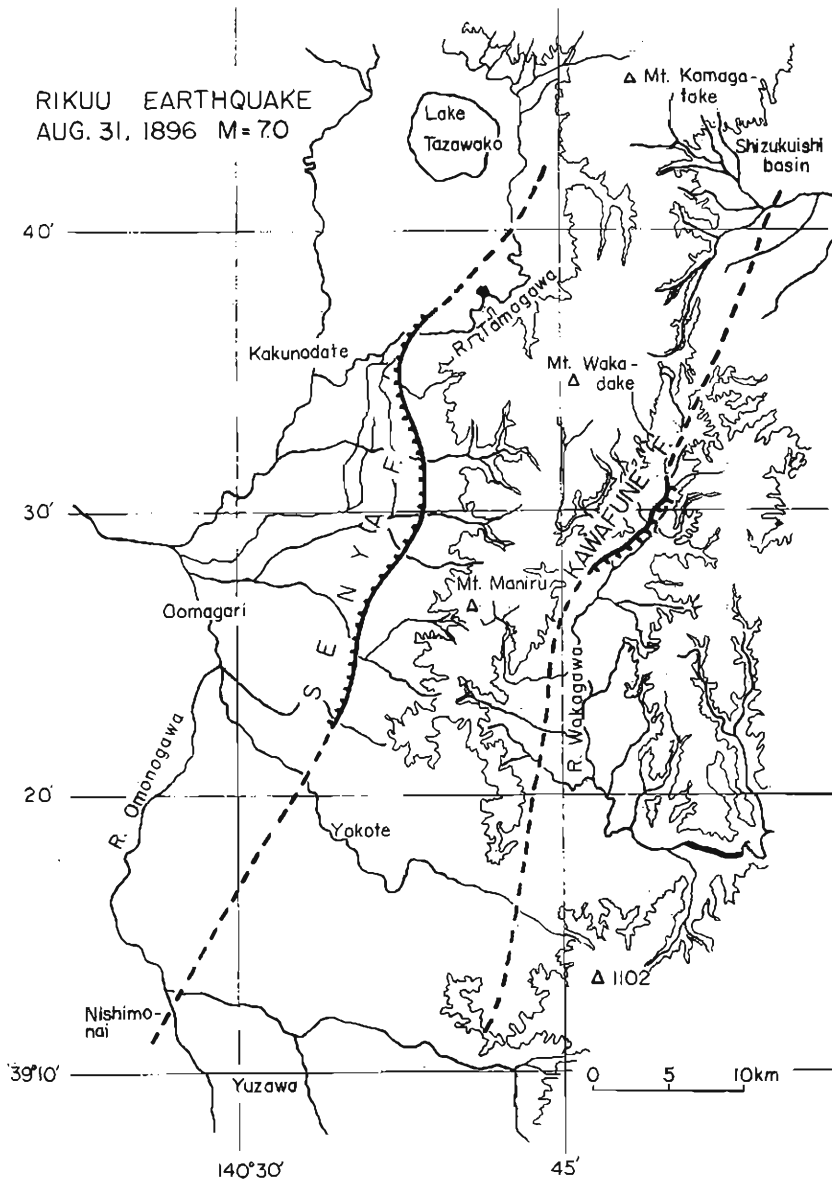
Fig. 4. Faults in the Rikuu earthquake.

**Rikuu Earthquake in 1896;** Two nearly parallel faults were formed in the earthquake; the Kawafune fault and the Senya fault (Fig. 4). The former is a reverse fault with its west side uplifted which was formed along the Wakadani valley on the east side of the Mahiru mountain ridge of NS trend. At the northern end of the fault, Ôaresawa in the Wakadani valley, it exhibited a vertical offset of 2 m, and extended southward through Wakahata, Yatsumata, Kôge, Kawafune, where also the west sides were uplifted by the order of 1 to 2 m, and further somewhat indistinctly toward the west of Ôta reaching about 15 km in total length. It is interesting to note the manner of faulting at Kawafune, where a road was crossed by the fault

lated parts are given in broken line in Fig. 4.

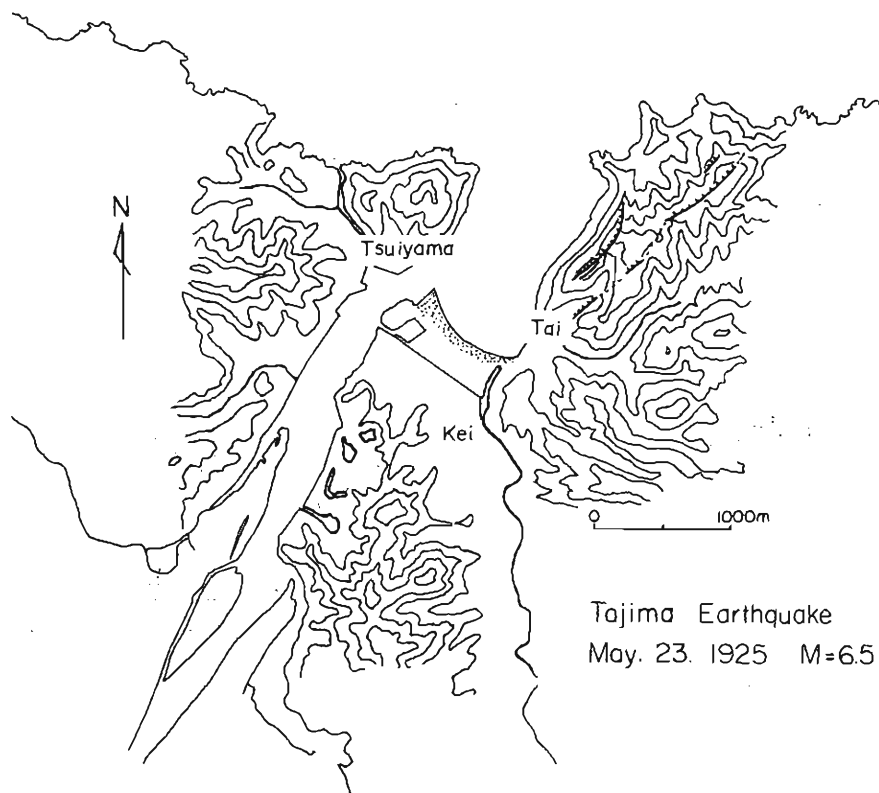
Fig. 7. Faults in the Tajima earthquake.

**Tajima Earthquake in 1925;** Two faults parallel to each other, the Tai West as well as Tai-East faults, were formed (Fig. 7)<sup>14</sup>. The former was 0.7 km long and the latter about 1.6 km long, and the distance between them was 400 m. The Tai-West fault ran from the cliff facing the Tsuiyama bay towards NW, with several fissures. It appeared on the mountain as a concentration of some ten fissures, which formed as a whole a graben-like depressed zone. The west side of the fault was subsided, however some fissures exhibited hinge-fault movement. The East fault

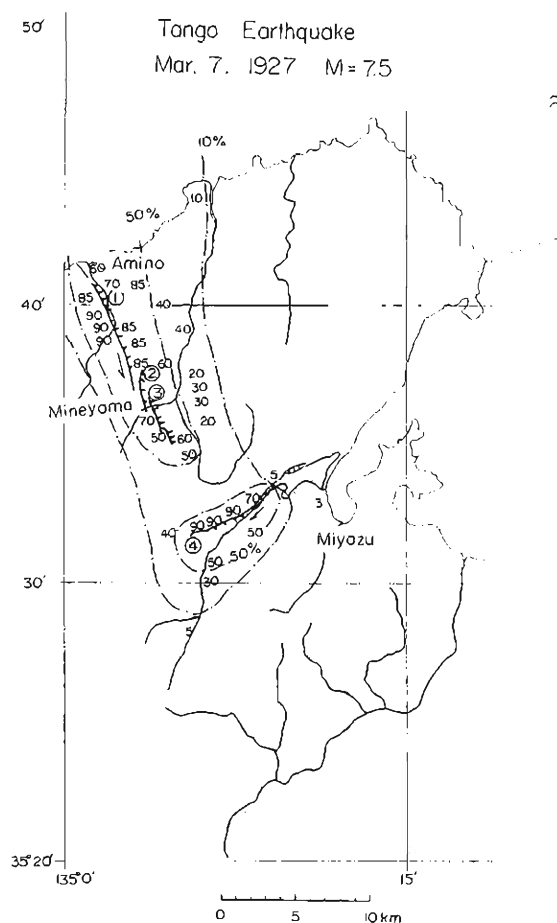
Fig. 8. Faults and percentages of totally collapsed houses in the Tango earthquake; ①; Takahashi fault, ②; Nimbari fault, ③; Nagaoka fault, above three together named the Gomura fault, and ④; Yamada fault.

**Tango Earthquake in 1927;** The Tango earthquake is characterized by a pair of very peculiar conjugate faults called the Gomura fault and the Yamada fault<sup>15)</sup>. The former crossed the Tango Peninsula from NW to SE, and the latter ran along the southern coast of the Peninsula from SW to NE composing a conjugate pair with the former (Fig. 8).

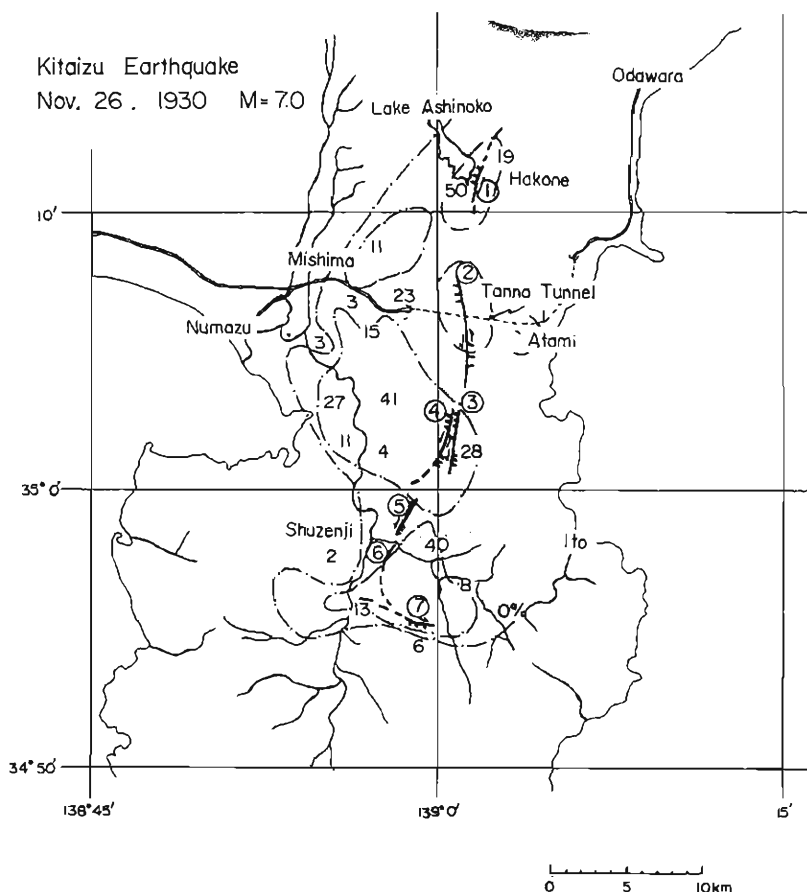
Fig. 9. Faults and percentages of totally collapsed houses in the Kitaizu earthquake; ①; Hakonemachi fault, ②; Tanna fault, ③; Ukihashi-Central fault, ④; Ukihashi-West fault, ⑤; Ōno fault, ⑥; Kadono fault, and ⑦; Himenoyu fault.

etc. are the latter (Fig. 9). Each fault constituting the main fault system is formed in échelon arrangement with gaps between each end of 1 to 5 km in the direction of strike and 1 to 2 km in the direction perpendicular to the strike. The amounts of offset across faults were 0.3 to 3.5 m in horizontal and 0.2 to 2.4 m in vertical direction. In contrast to a consistent sense of slip in horizontal component the vertical ones at faults of NS trend were variable, and especially the Tanna, both Ukihashi, Ōno, and Kadono faults proved to be hinge faults, i.e. the east sides were uplifted in the northern parts and the west sides in the southern parts, while the movements were consistently left lateral in the horizontal component. According to Kuno<sup>17)</sup> the west side should be uplifted in the southern part and its extension of the Tanna fault, but it was not very distinct in this earthquake. In Karuizawa in the Tanna Basin the drying up of wells and a strange phenomenon, where radishes were thrown out of soil are reported<sup>18)</sup>. The Tanna tunnel, JNR, under construction suffered damage

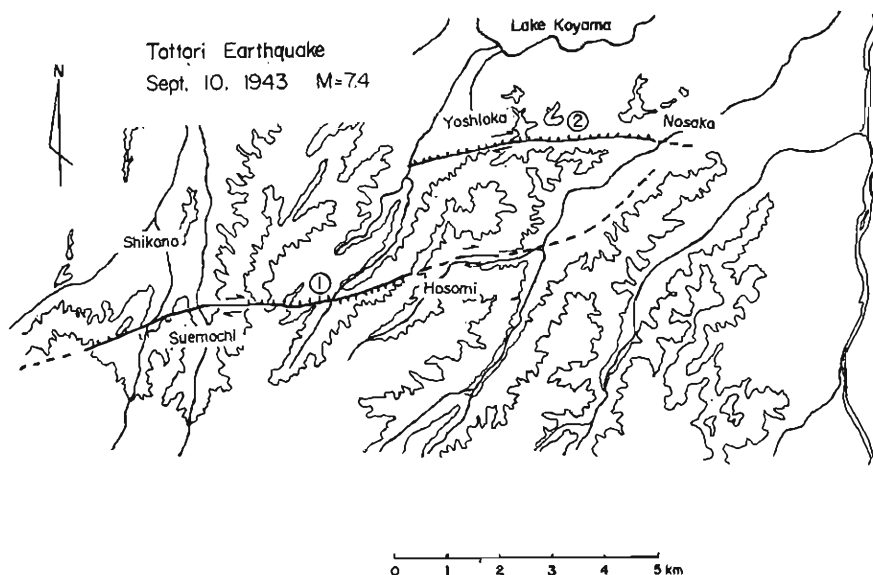
Fig. 10. Faults in the Tottori earthquake; ①; Shikano fault, and ②; Yoshioka fault.

The positions of the two faults are en échelon, and it cannot be determined which may be the main or the secondary, since they have comparative lengths and displacements. The normal distance between the both faults is about 2 km, however it is also possible that they join together underground near Nosaka (See Fig. 10).

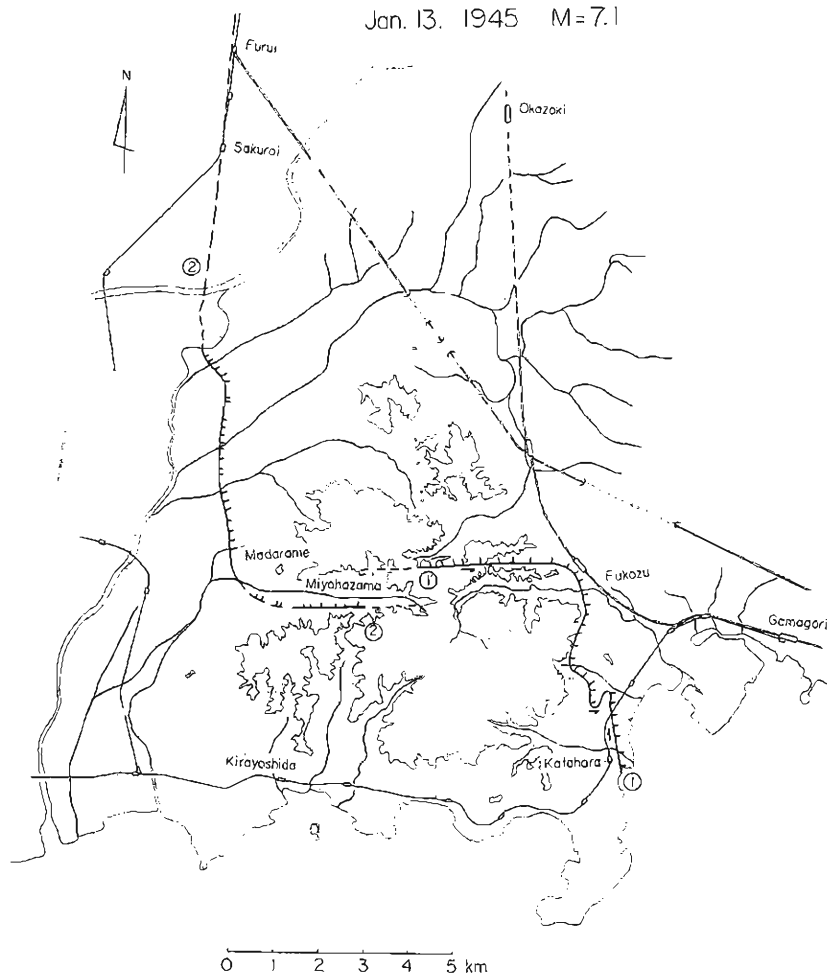
Fig. 11. Faults in the Mikawa earthquake; ①; Fukoju fault, and ②; Yokosuka fault.

**Mikawa Earthquake in 1945;** Two very peculiar faults were formed in this earthquake, i.e. the Katahara fault or the Fukôzu fault and the Yokosuka fault (Fig. 11). The former has been described by Tsuya<sup>21</sup> in detail. It starts at the right bank of the Otowagawa river in Katahara town toward north, bends to west at Maeno and extends as long as about 500 m, turns there NNW and goes 2.75 km as far as Fukôzu, and there again turns to the West and proceeds along the Sakagawa river on the north

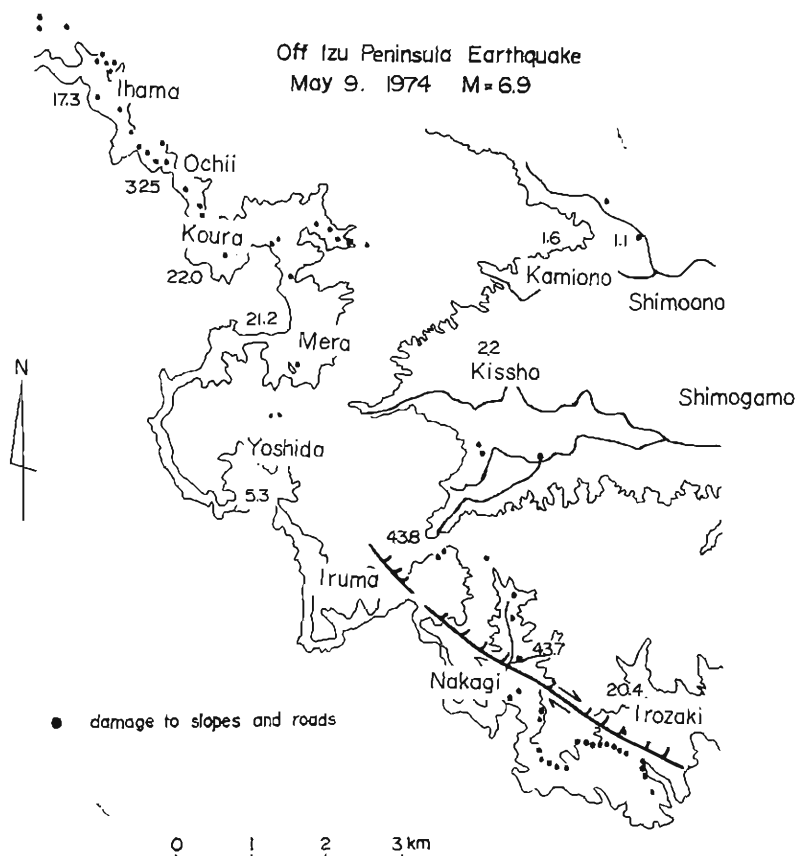
Fig. 13. Faulting in the off Izu-Peninsula earthquake and distribution of damage to slopes and roads.

**Off Izu Peninsula Earthquake, 1974;** In the earthquake of M 6.9 an evident right-lateral fault named Irôzaki-Central fault was formed traversing Irôzaki with a strike of NW-SE (Fig. 13). The fault appeared as a clear cut with an offset of 35 cm in horizontal and 17 cm in vertical at an andesitic rock cliff at the east end of the town. It traversed that locality forming en échelon fissuring, which caused breakage of many foundations of houses, crossed a road causing a slope failure, and extended toward NW in the mountainous region. It seems to have passed marginally the mountain side of the road connecting Irôzaki with other western sites at the point above Nakagi, destroying a tunnel on the road. After crossing this road at NW of the tunnel the fault extended further toward NW and became indistinct in the mountains.

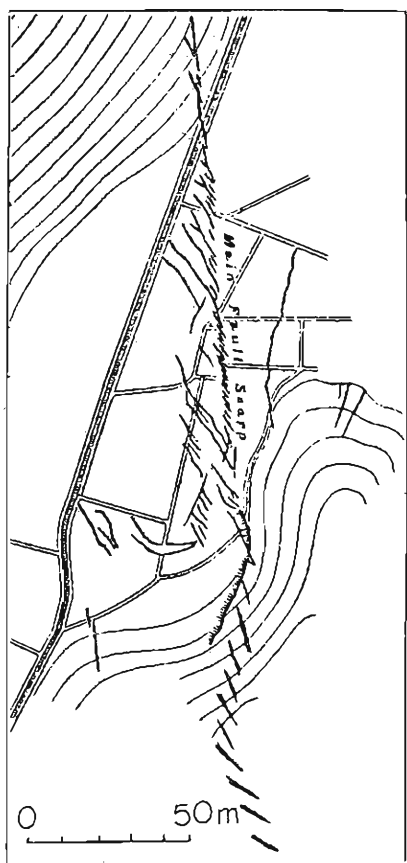
Fig. 14. Cracks en échelon along the left-lateral Gomura fault in the Tango earthquake. (reproduced from Yamasaki)

In soft soil areas cracks en échelon are observed very often (Fig. 14). This type of crack has been experienced in the Tango, Tottori, Mikawa, and the Izu-Peninsula earthquakes. They occur mostly in soft sediments and sometimes also in soft rocks.

In the Tango earthquake a series of cracks en échelon as shown in Fig. 14, were formed along the left-lateral Gomura fault. It is evident that these cracks were caused by tensile stress due to shear. In the Tottori earthquake also a series of cracks with strikes  $N50^{\circ}$ – $80^{\circ}$ W were observed along the right-lateral Shikano fault in the EW direction, which also suggests the same cause of these cracks.

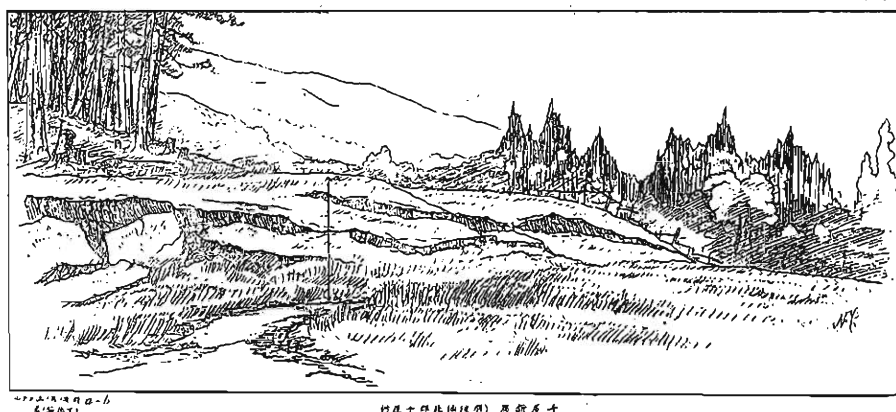
Fig. 15. Mole tracks along the Senya fault in the Rikuu earthquake. (reproduced from a sketch by Yamasaki)

Mole tracks along the intersection of a reverse fault with the ground surface are also observed very often, e.g. in the Nobi, Rikuu, Tajima, Tango, Mikawa earthquakes, etc. They occur in general in soil or soft rocks, while in hard rocks a fault appears as a clear cut. An appearance of the phenomenon along the Senya fault in the Rikuu earthquake is reproduced from a sketch by Yamasaki (Fig. 15). This phenomenon was especially remarkable in the Mikawa earthquake, where a zone 40 to 60 m wide was upheaved, causing a height difference up to 2 m between the both sides of the zone (Fig. 16). Houses and other structures on the upheaved zone were inclined up to about 10 degrees. A wavy swelling or gentle flexure of the ground

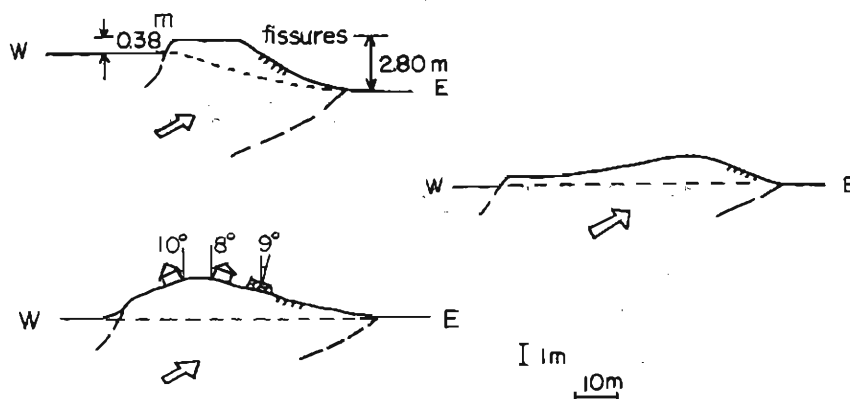
Fig. 16. Mole tracks along the Fukôzu fault in the Mikawa earthquake. (illustrated after Inouye)

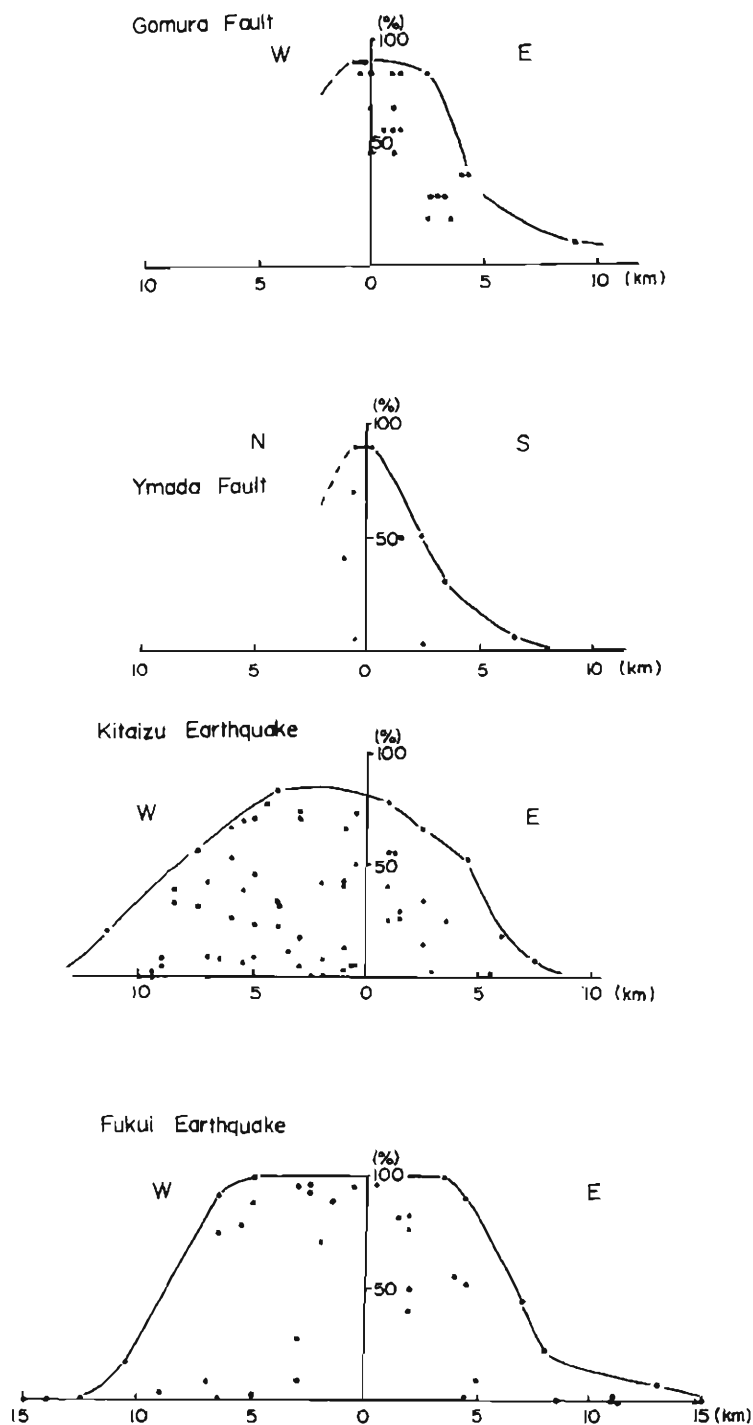
Fig. 17. Percentages of totally collapsed houses versus distance from the fault line in the Tango ( $M=7.5$ ), Kita-Izu ( $M=7.0$ ), and Fukui earthquake ( $M=7.3$ ).

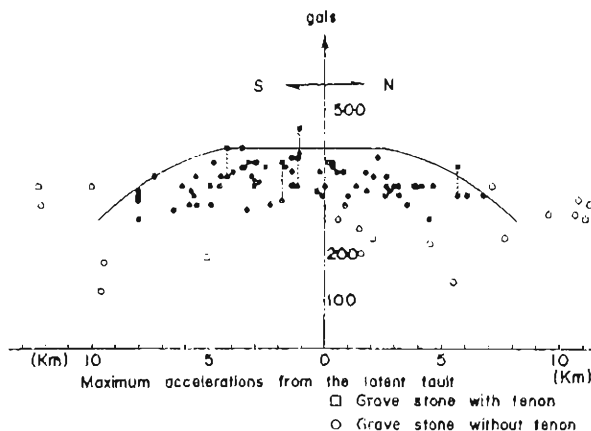
Fig. 18. Maximum accelerations versus distance from the postulated fault line in the Central-Oita earthquake. (reproduced from Omote)

Recently, Omote et al.<sup>26)</sup> investigated the distribution of overturned gravestones in the Central-Ōita earthquake of M 6.4 and estimated the maximum accelerations versus the distance from the latent fault postulated from the concentration of damage as shown in Fig. 18. In the figure it is evident that the maximum accelerations drop rapidly from about 5 km on. The result seems to meet the experiences described above.

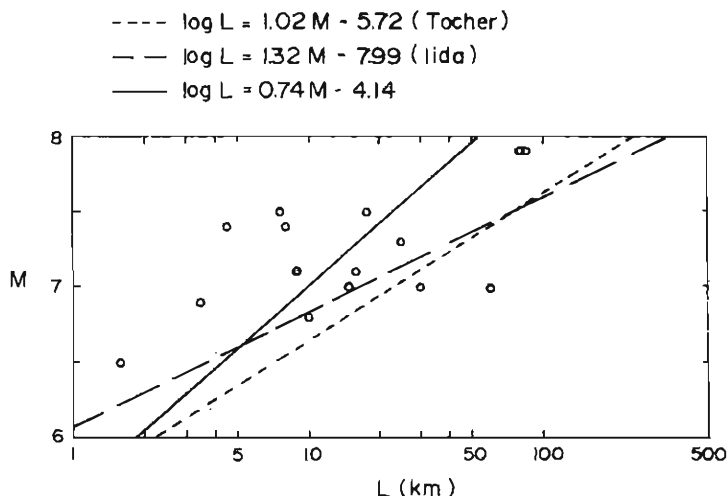
Fig. 19. Earthquake magnitude and the length of fault in the earthquakes given in Table I.

and corresponding lines by Tocher as well as by Iida are also indicated. The last expression is close to the formula proposed quite recently by Matsuda<sup>30)</sup> giving  $L=80$  km at  $M=8$  and  $L=20$  km at  $M=7$ ;

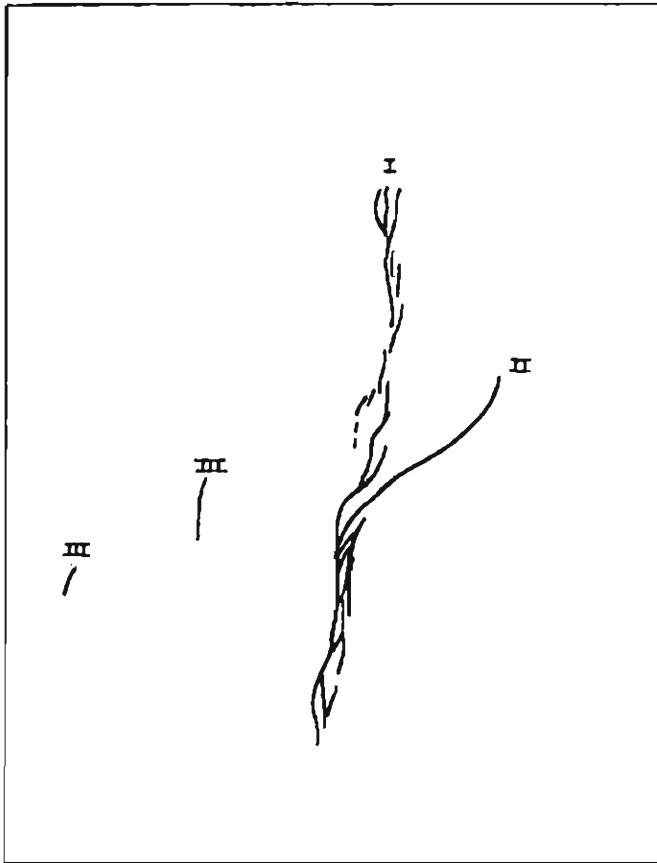
Fig. 20. Diagram showing (I) main fault zone, (II) branch fault, and (III) secondary faults. (reproduced from Bonilla)

Bonilla<sup>31)</sup> classified the earthquake faults into main, branch, and secondary faults, which have been employed in the preceding pages. The classification illustrated in Fig. 20. applies also to Japanese faults in many cases, but it seems not to be very appropriate for cases as the Rikuu, Tajima, Tango, Tottori, and probably the Mikawa earthquakes too, where two faults with dimensions of equal order were formed and it was impossible to judge which was the main. Also in other earthquakes the main fault was in general not a single connected rupture, but several segments en échelon appeared, forming an aggregated main fault system.

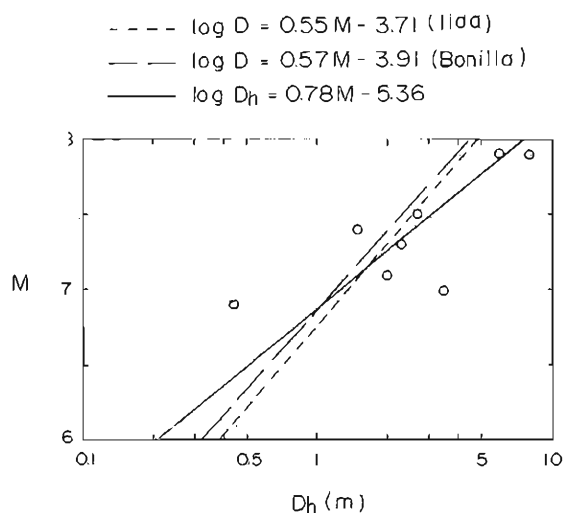
Fig. 21. Earthquake magnitude and the maximum horizontal displacement on fault in the earthquakes given in Table 1.

In hazard assessment the significance of horizontal and vertical displacements are different, and the amounts in the horizontal and vertical directions in Table 1 are plotted separately in Fig. 21 and 22. Empirical equations by the method of least square are

for the horizontal and vertical displacements, respectively. The relations by Iida as well as by Bonilla are also given in the figures.

From Table 1 or Fig. 21 and 22 it is noted that the horizontal displacement is predominant in Japanese faults. The cases  $D_h > D_v$  are the Nobi, Kanto, Tango, Kita-Izu, Tottori, Fukui and the off Izu-Peninsula earthquakes, while the cases  $D_h < D_v$  are the Shonai, Rikuu, Tajima, and Mikawa earthquakes. In the latter group the result on the Shonai event is unreliable, and moreover also in the Rikuu earthquake, where only the value of  $D_v$  is reported, it is not very certain that there was no horizontal displacement, since the horizontal shift is more difficult to determine than the vertical one without detailed survey.

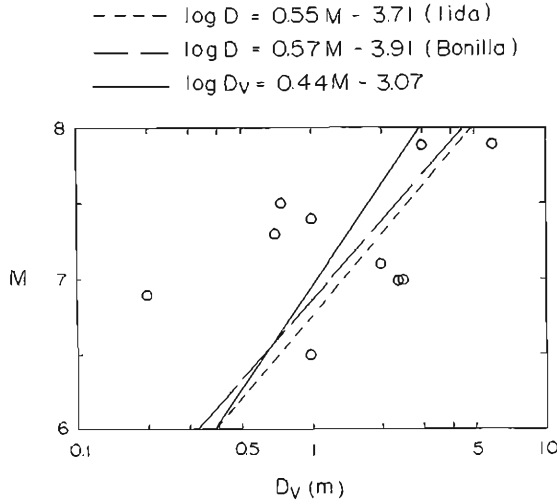
Fig. 22. Earthquake magnitude and the maximum vertical displacement on fault in the earthquakes given in Table 1.

$$\log_{10} D_v(m) = 0.44M - 3.07$$
